PIPELINE REPAIR

Project type:	Power station gas supply pipeline repair
Location:	Pasir Gudang, Johor, Malaysia
Description:	1.5 km gas pipeline 10" to 24" diameter pipe, flanges and valves
Area coated:	2950m ²
Coating system:	2 x 300 micron coats 28.15 1 x 50 micron PU topcoat Enviropeel encapsulation of bolted systems
Surface Prep:	Blasted SA2/2.5 and Power Tool ST2 50-100 micron profile

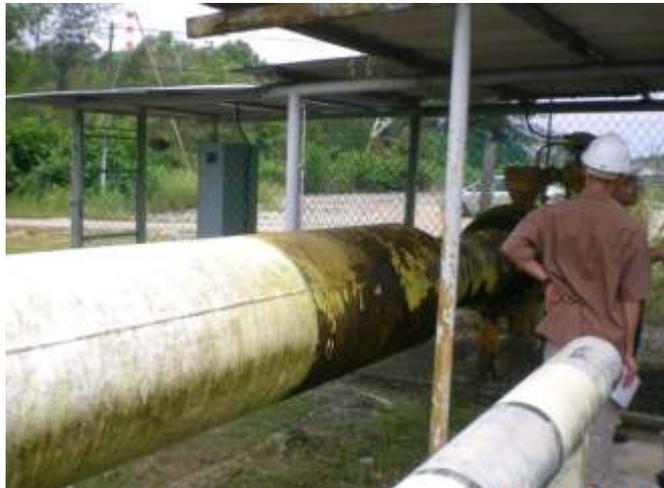
Gas pipelines at the TNB Power Station in Johor, Malaysia required repair and refurbishment as the polyethylene tape wrap system was failing. Penetration of the wrapping system entrapped moisture causing rapid spread of corrosion throughout the 1.5 km of pipe. Stagnant, permanently wet conditions such as those created within failed wrapping systems creates pitting corrosion which can lead to significant reductions in metal thickness and threaten pipeline integrity.

Above: the tape-wrap system has become a threat to the pipeline instead of protecting it. Rust products streaming from within the coating have stained the concrete supports.

First the failing wrap was removed, then surface preparation using a combination of blasting and power tools was undertaken. Two coats of Alocit 28.15 were carefully applied, with particular attention to coverage within pitted areas. Finally a cosmetic coat of a compatible PU was used.

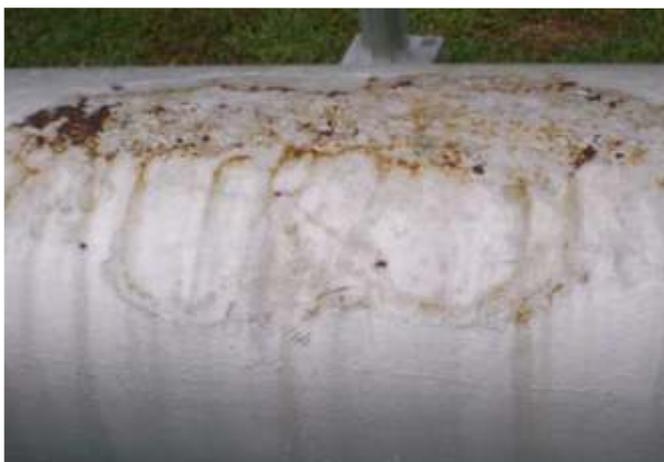
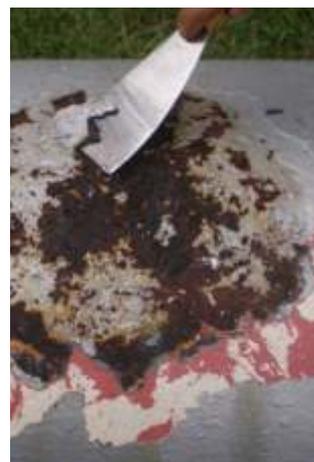
Left & below: removal of the wrapping reveals significant corrosion, including blistering paint and pitting caused by trapped water.

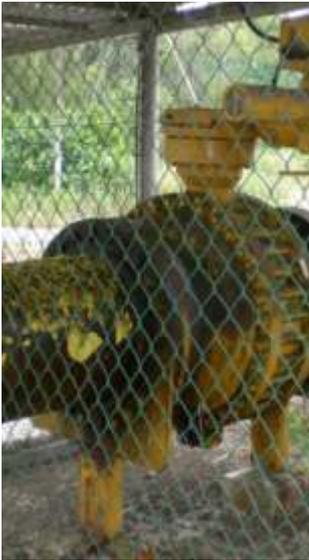
Left: although still serviceable, if the flanges on this system were left for much longer, bolt integrity would be compromised

Once the painting was completed, all the bolted flange joints were protected with Enviropeel as, even when blasted and painted, bolted systems are prone to failure. Enviropeel encapsulation provides a whole system, active protection that prevents the recurrence of rust.

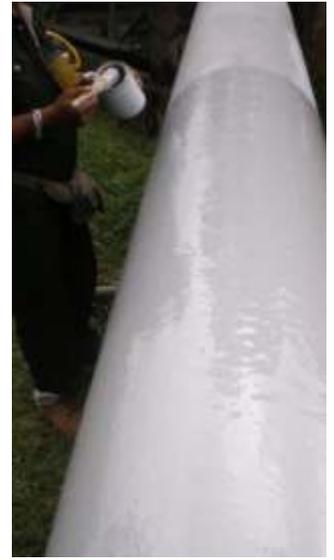
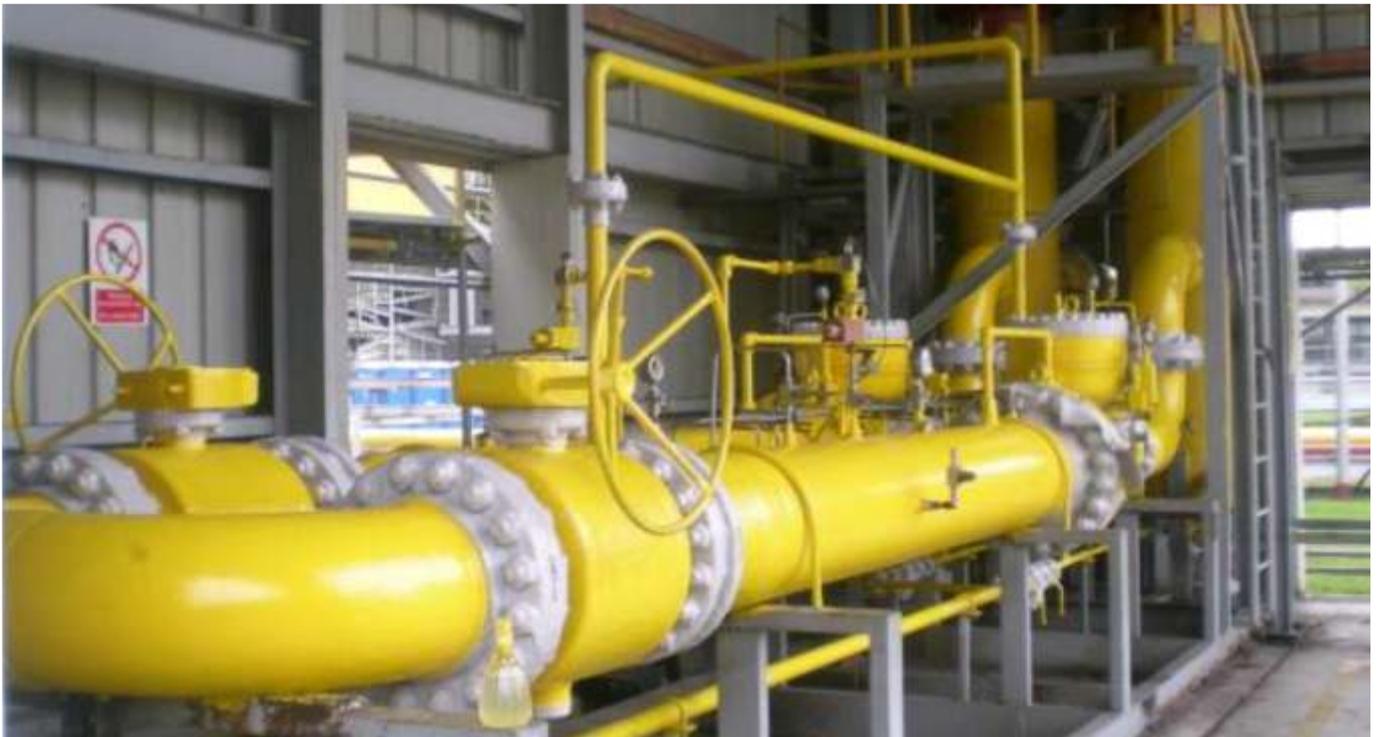
Right and below: Alocit 28.15 provides an extremely hard, long-lasting finish with Enviropeel providing the best possible protection for complex bolted areas.
