Flange Joint Protection in the North Sea

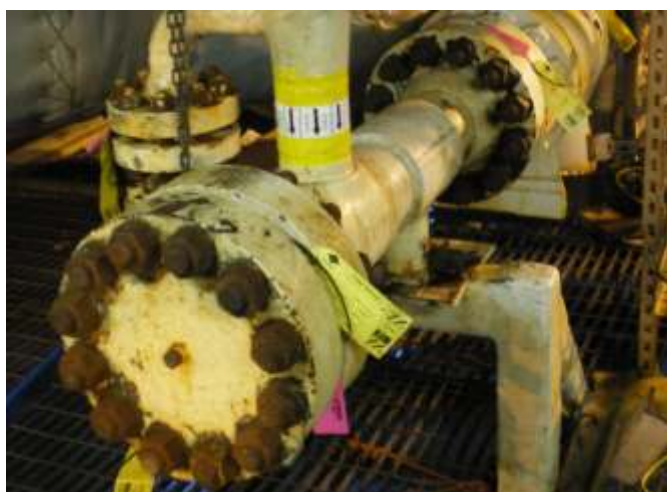
Above: Typical signs of bolt corrosion on the new platform
