# CONTAINER CRANE

**ENVIROPEEL**  
THERMOPLASTIC SYSTEMS

A major Australian stevedoring company was looking for a solution to the problem of corrosion on the cleats and pigtails of their aging mobile portainer crane servicing the Fremantle Port. Of paramount concern to the operators was the potential hazard to wharf workers below if parts were to break free. Enviropeel was applied to prevent corrosion damage and secure the components to the crane platform and jib.

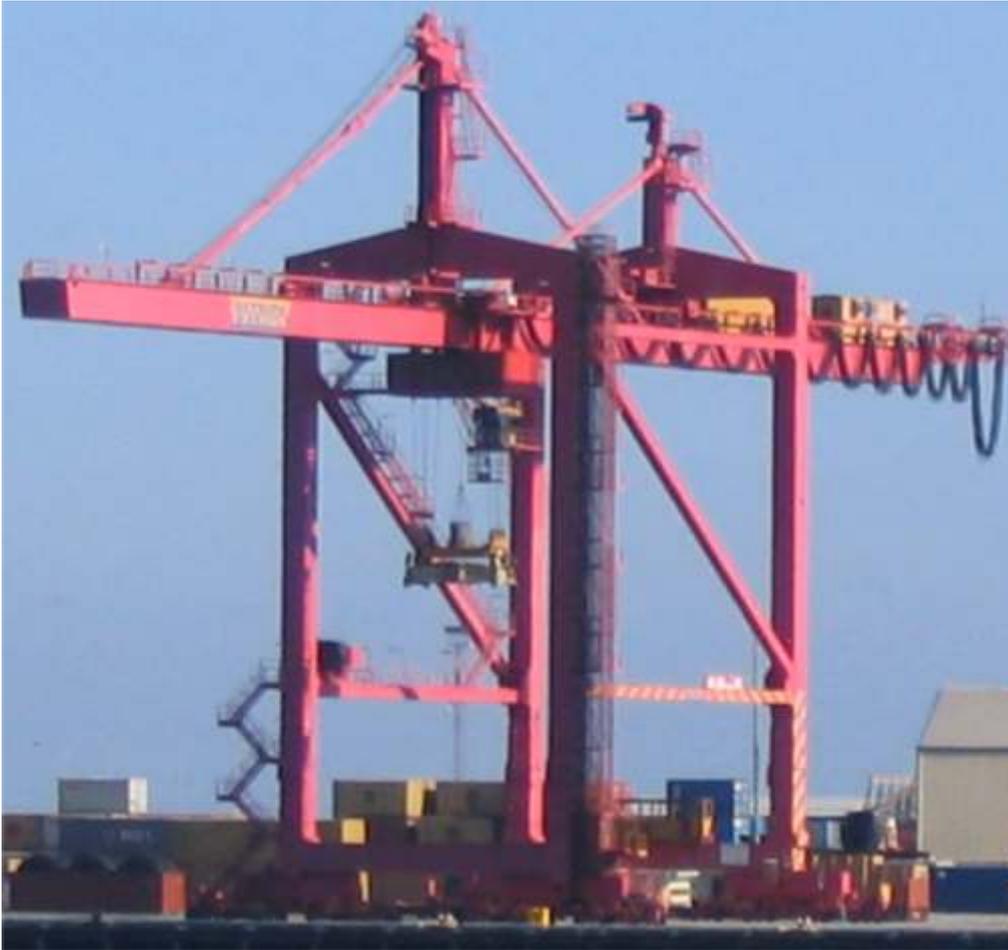
*Above: A view of the Fremantle Port Portainer Crane*

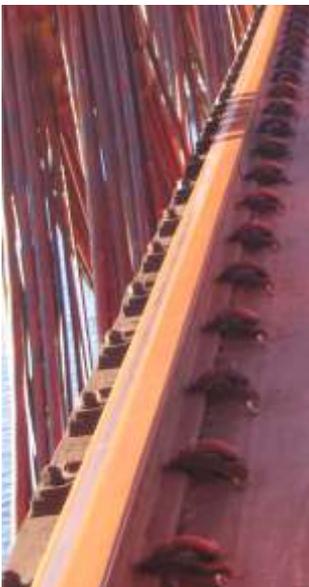
The cleats and pigtails securing the rails on the crane platform suffered severe corrosion caused by the marine environment and exposure to high winds, rain and extreme variations in temperature. The corrosion made them prone to breaking free and created a falling debris hazard for personnel working below.

*Left: A length of track on the crane platform showing the corroded cleats and pigtails*

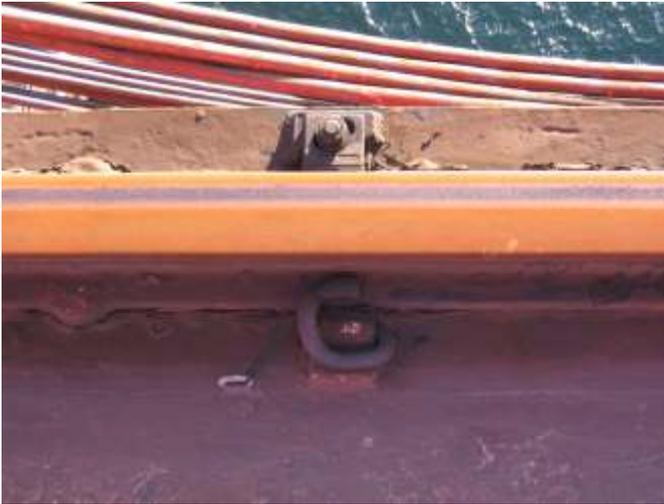
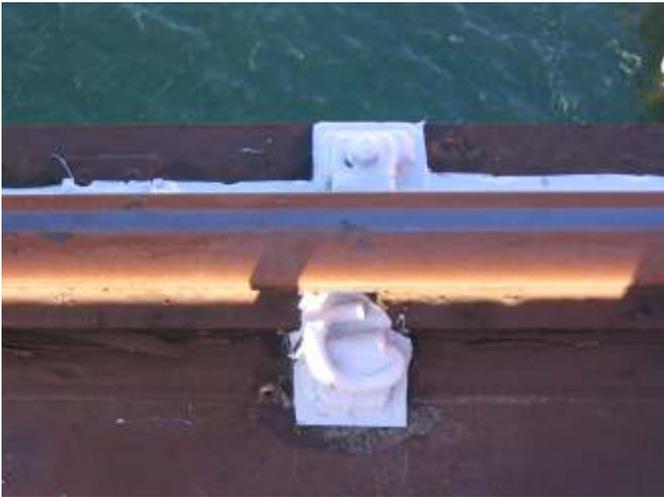
Top: A single cleat and pigtail prior to coating  
 Above: Cleat and pigtail after being coated with Enviropeel

The Enviropeel coating was essential to stop corrosion and prevent separation. For extra security an additional 'strip' was applied to link the outside cleats to each other. Surface preparation was minimal, requiring no more than a brush down of loose material and dirt. The elongated bolt holes on the cleats and the irregular curved shape of the pigtails allowed the Enviropeel to flow beneath the nuts and around the pigtails thereby 'locking' the material in place, pull checks on the set Enviropeel confirmed the encapsulation of the material with the substrate. In total 208 cleats on the outside of the rail and 104 pigtails were coated with Enviropeel to complete the work.

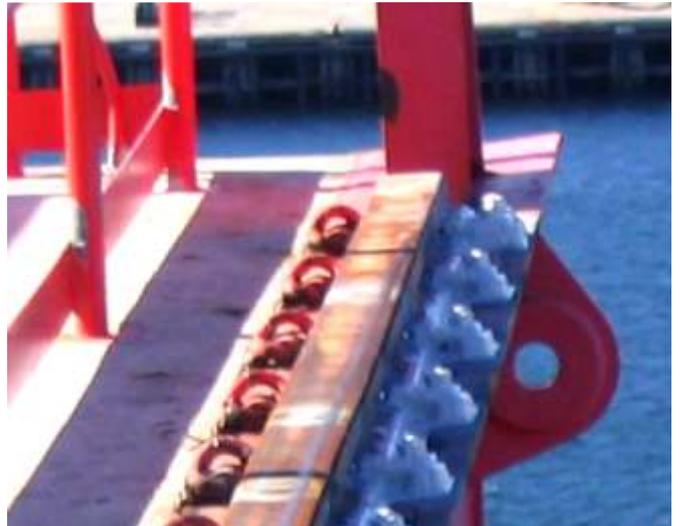
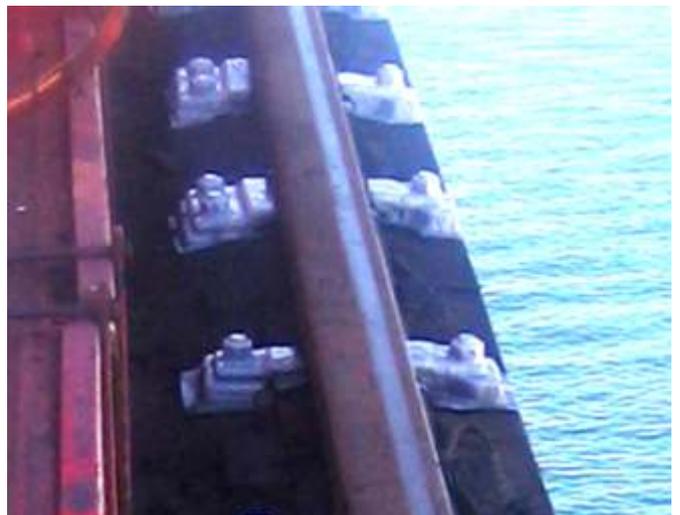
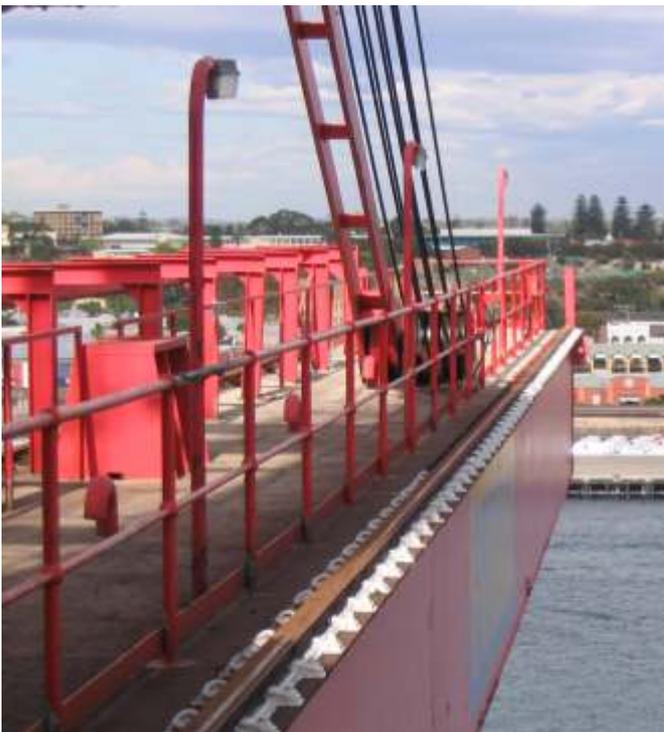
Right: A length of track on the jib showing coated cleats linked with Enviropeel to improve security  
 Below Right: Views of Enviropeel coated cleats
