Flange Joint Protection in the North Sea

ENVIROPEEL
THERMOPLASTIC SYSTEMS

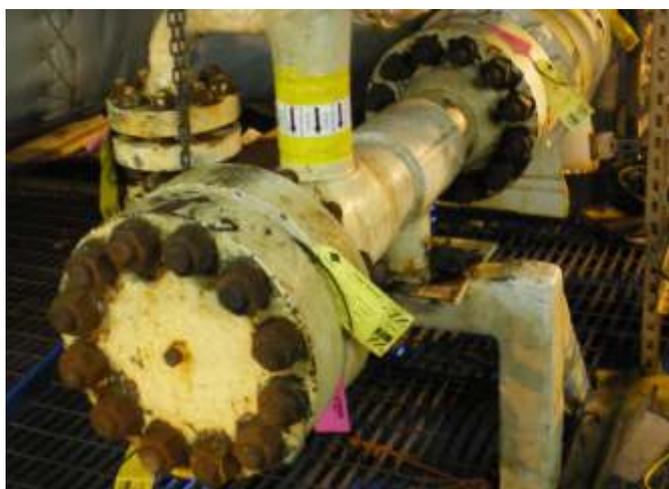
Above: Typical signs of bolt corrosion on the new platform

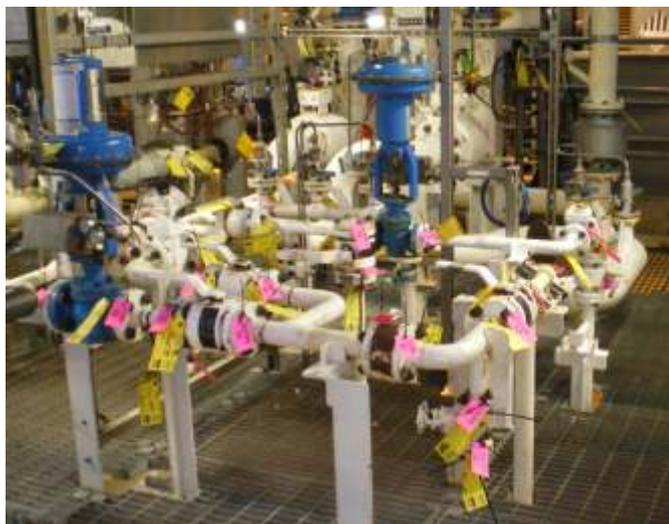
Below: Identifying the systems and joints was one of the first challenges for the A&E teams - with separate isometrics for each of 25 systems and a carnival of tags on every level.

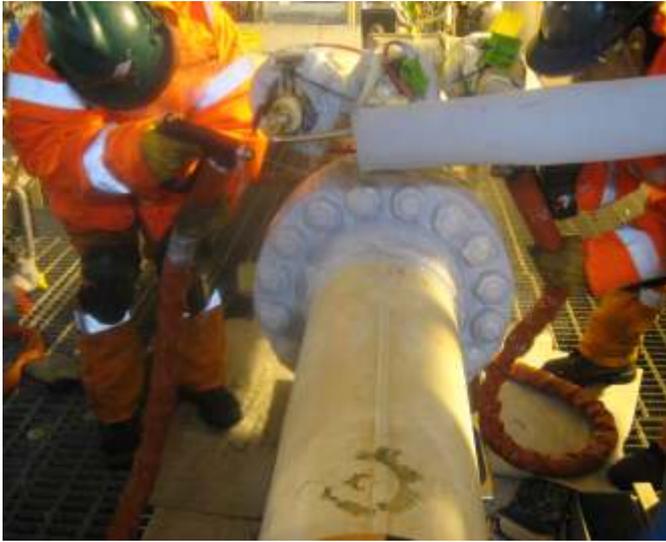
Left: two applicators work from either side of a large flange joint.

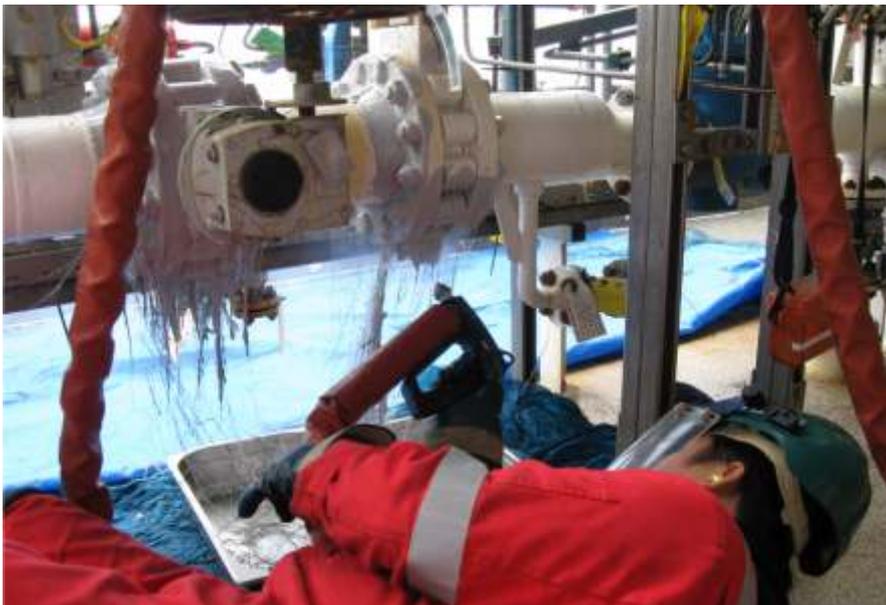
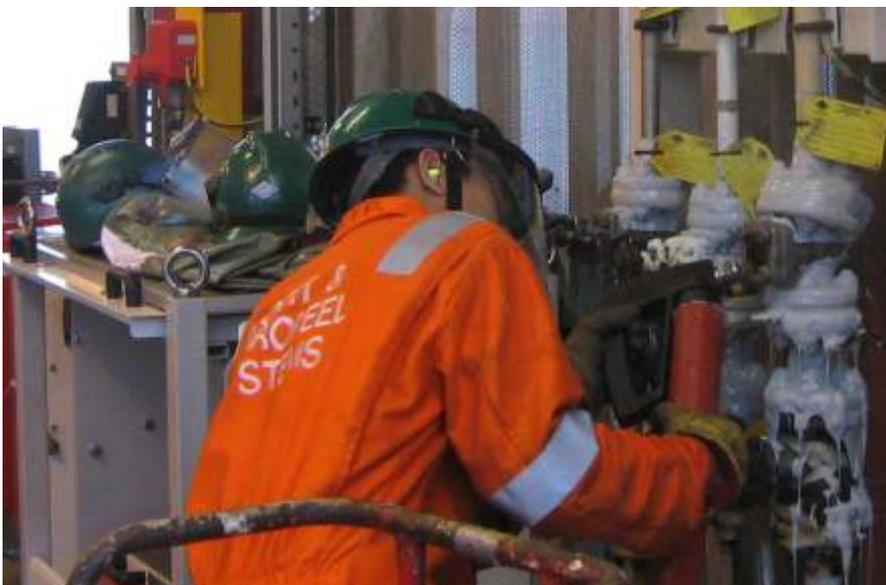
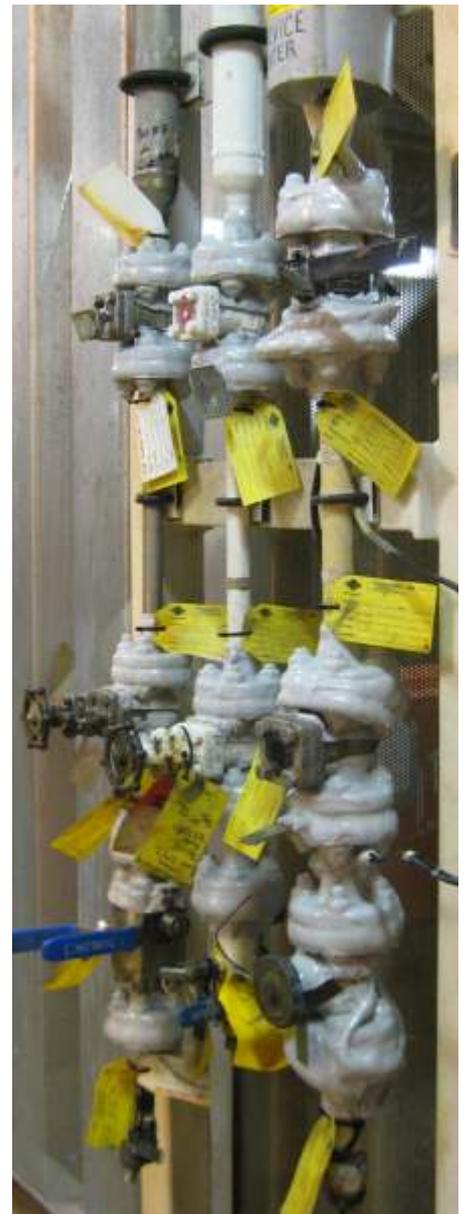
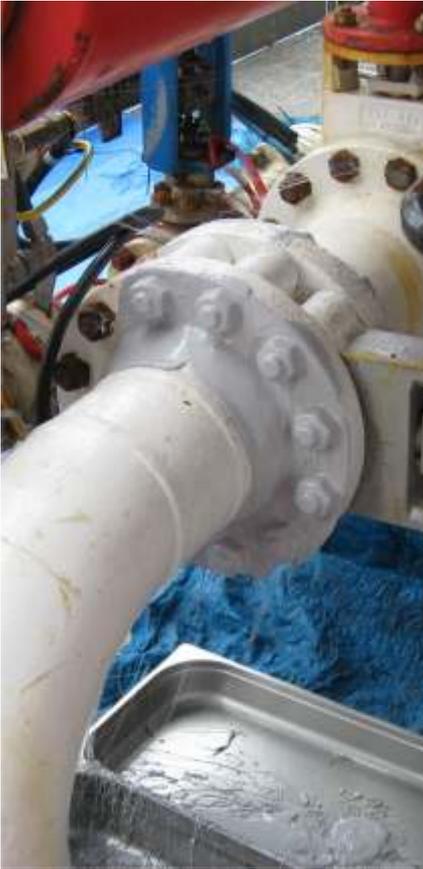
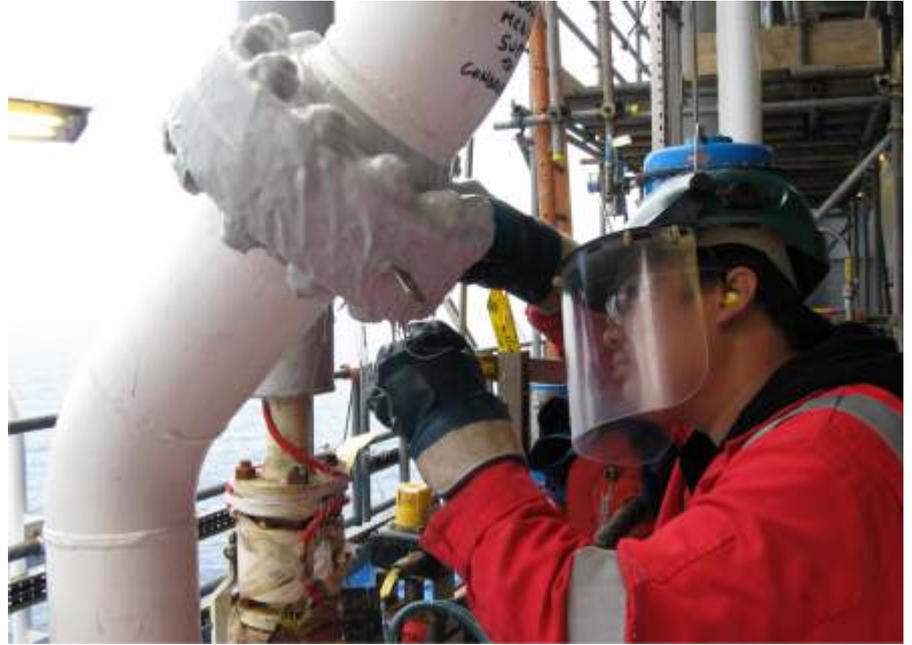
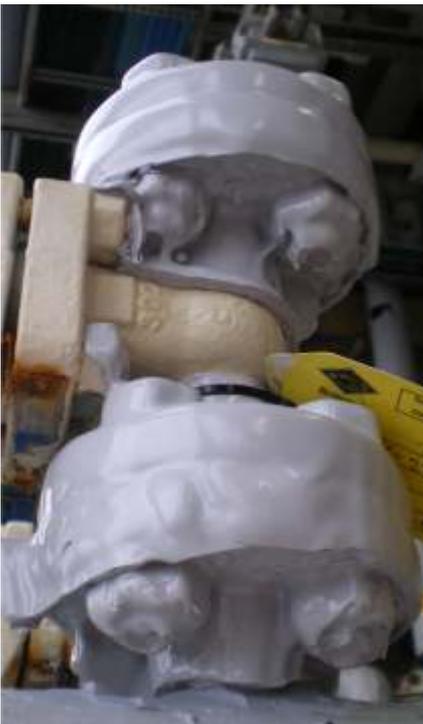
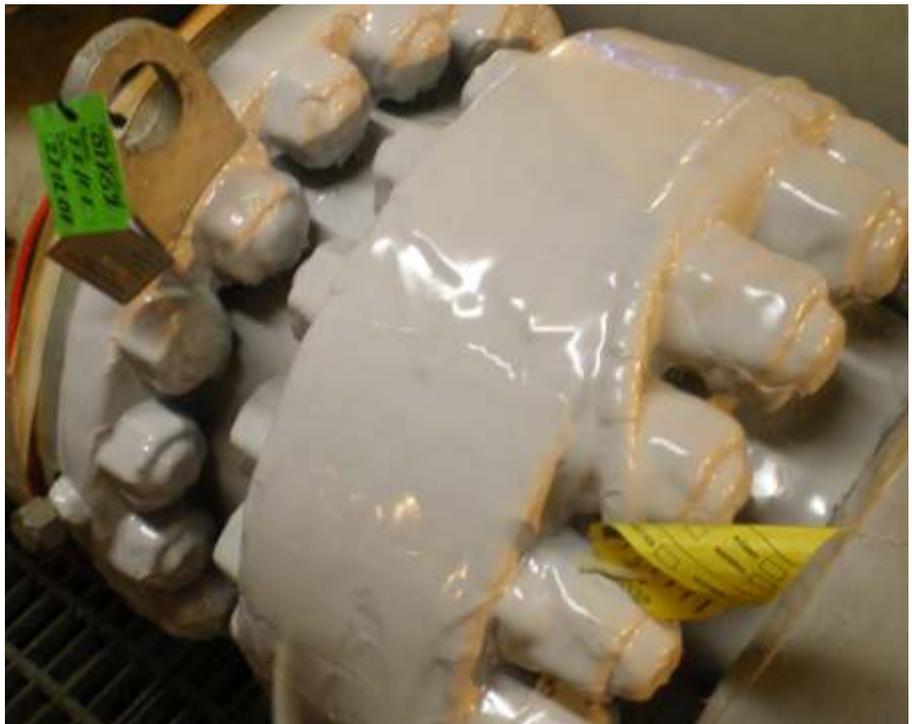
Below: during application a joint can look messy, but once both coats are completed and trimmed the joints look, and are, ready for the worst conditions the North Sea can throw at them!

Application builds coats in succession, working from underneath, around the sides and finally above with two coats to provide maximum protection. The underside is the most difficult area to finish aesthetically but trimming between and after each coat ensures full protection. All trimmings and drips/spills are collected and recycled.

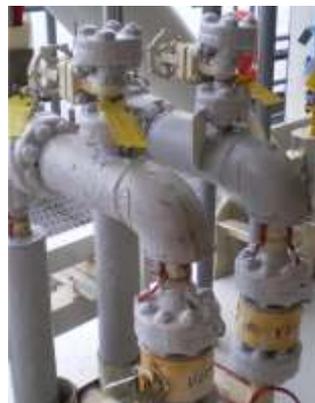
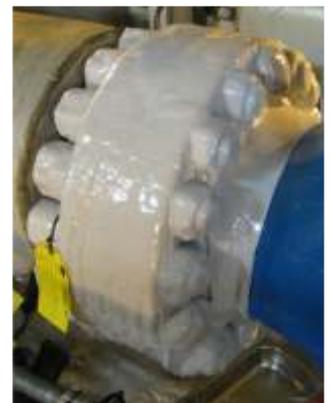
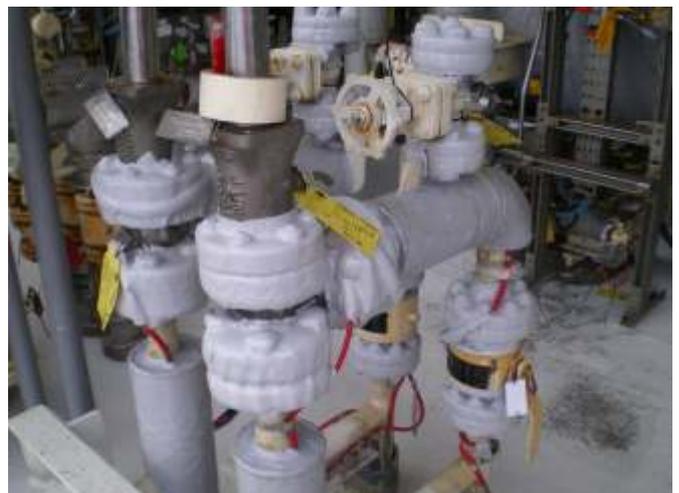
Right and above: A review of the finished applications shows the high standards maintained throughout the project.
