WASTE WATER PLANT

The central sewage plant in Konstanz, Germany was built in seven stages between 1968 and 1982. It is a mechanical-biological plant with phosphorous precipitation and anaerobic sludge treatment, the gas produced in the process being used to provide 60% of the unit's power requirements. 30 years after the first Alocit coatings were used to protect concrete on the 5,660 m³ buffer and interconnecting 8,200 m³ rainwater settling tanks, Alocit was used again. But not on the originally protected concrete - the original coatings were still in perfect condition - this time it was on vulnerable parts of the screen and grit chamber structures.

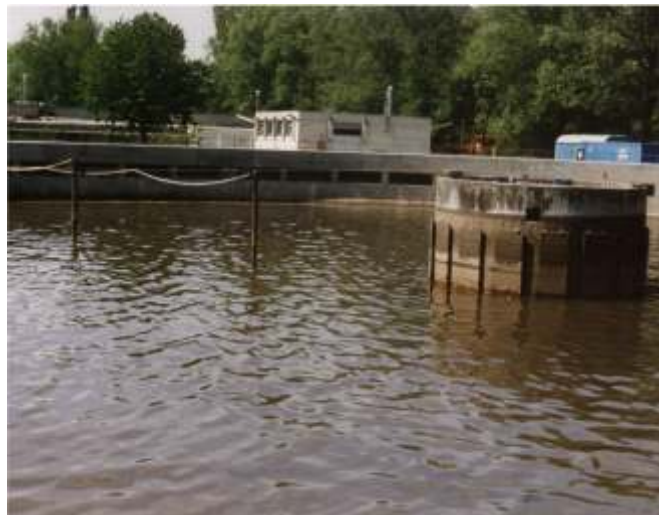
Work started in April 1996 on individual sections. First high pressure water jets (up to 1800 bar) were used to remove old failed coating and the resulting chemically damaged concrete. Exposed corroded reinforcements had

the rust removed and the application of mineral based protection. Then, with surface roughness generally at 2-3mm and in some places 8mm because of widely differing concrete quality and damage due to chemical attack in the concrete zones close to the surface, the walls and floors were reprofiled using a mineral surface filler to provide a smooth base for the Alocit primer and coatings.

The total thickness of the Alocit coating system when dry was specified as 600 microns on the walls and 1000 microns on the floors. The original Alocit coating specification was used - the primer was Alocit 28.95 and the top coat was Alocit 28.15. All of the coatings were applied by hand roller.

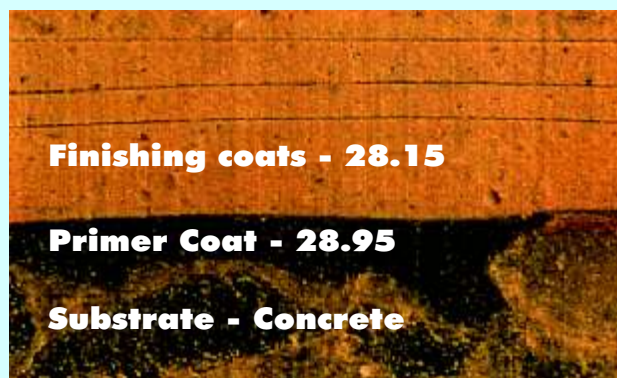
Shown right: A magnified section of a core sample with the four coats clearly showing. Note how the primer coat penetrates and smooths the substrate. Diagram on left shows areas referred to in the chart above.

Throughout the project coatings were regularly tested for quality. Drill cores were taken during the repair process and verified by laboratory testing. During the individual operating stages tests were carried out on site, including adhesion tensile tests and dry film thickness tests, all of which provided excellent results. The chart on the left shows that, during adhesion tests, there was only failure in the substrate - the Alocit coating remained secure. The second chart shows a sample of the DFT tests which showed excellent coverage throughout the project.
