USS DETROIT (AOE-4) SECNAV/NAVSEA

Capital Investment Labor Initiative (CILI) 1-Year Evaluation Bilge Application

A test application in the Port Shaft Alley Bilge
OF

Original Application February - April 2000
1 Year Follow-up Survey May 2001

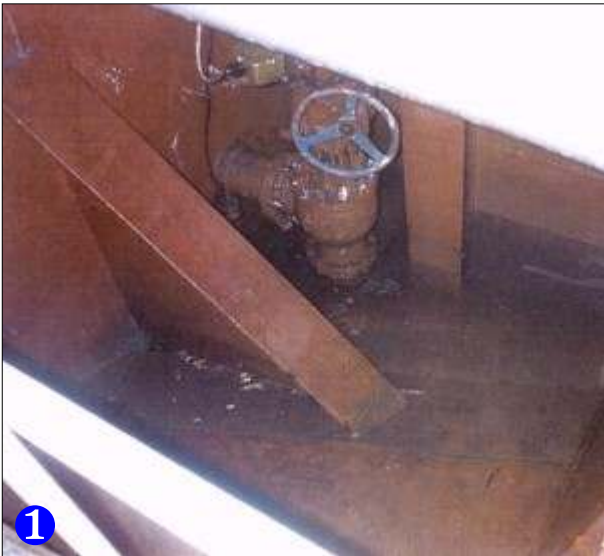
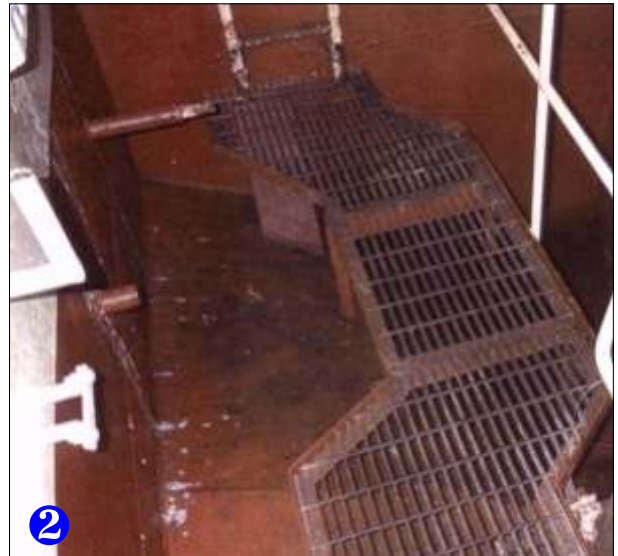
The shaft alley was surveyed May 2001 while USS Detroit was at home port at NWS Earle, NJ. **The Alocit Aquacoat coating system is in immaculate condition with no deterioration of any kind noted.** There is standing salt water in the sump area and some mold and mildew growing (the ventilation in this space is poor). There was no corrosion of any type noted. Much of the steel in this space (bilge) is heavily pitted and without this re-preservation would be holed through (some steel replacement was accomplished in conjunction with the re-preservation in 2000).

The bilge is in excellent shape with no corrosion or coatings failure noted

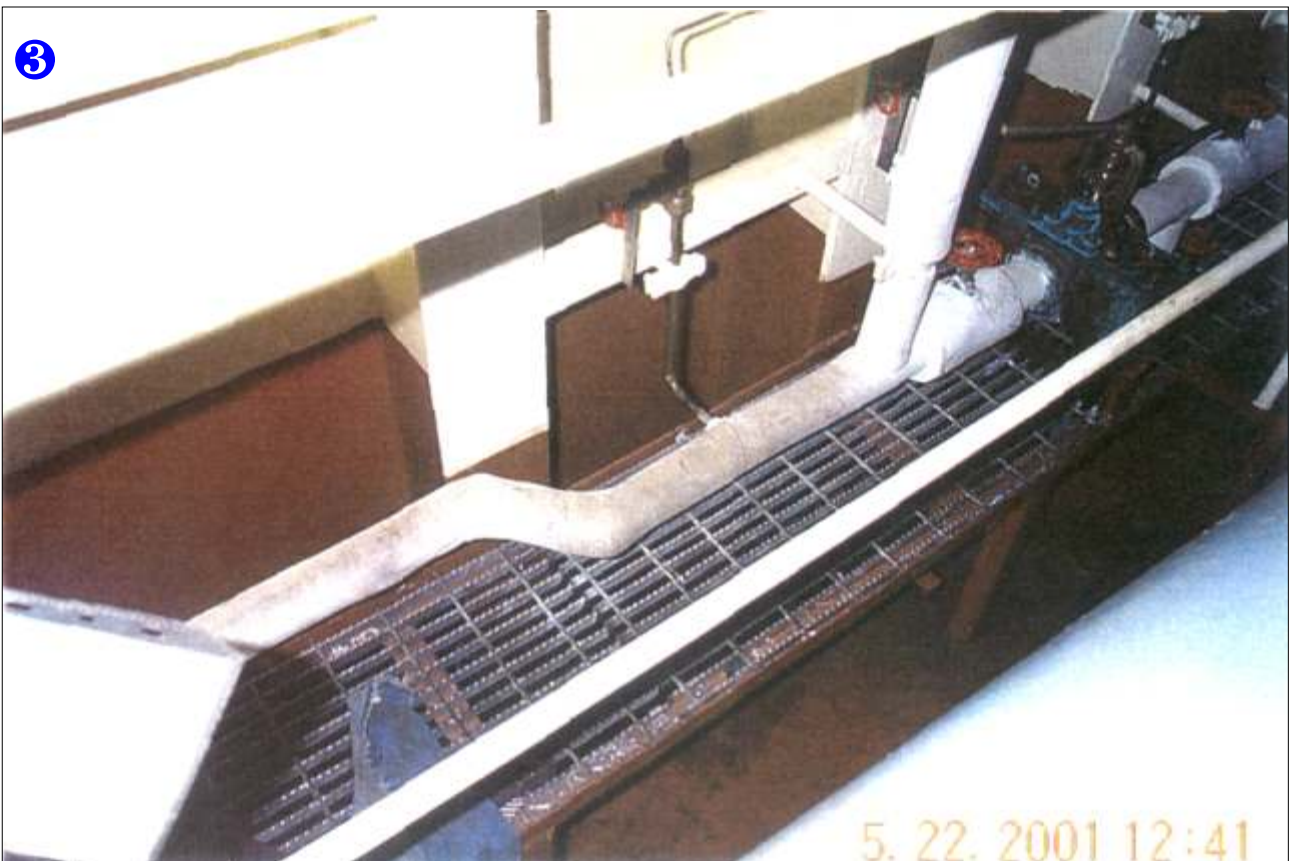
- 1 Forward Stb'd corner of the bilge. The sump area shows no sign of any deterioration
- 2 Due to continual damp conditions and minimum ventilation mold and mildew can be found
- 3 The Alocit Aquacoat is performing flawlessly in severe service
