**USS DETROIT (AOE-4)
SECNAV/NAVSEA**

**Capital Investment Labor Initiative (CILI)
1-Year Evaluation Bilge Application**

A test application in the Port Shaft Alley Bilge
OF

Original Application February - April 2000
1 Year Follow-up Survey May 2001

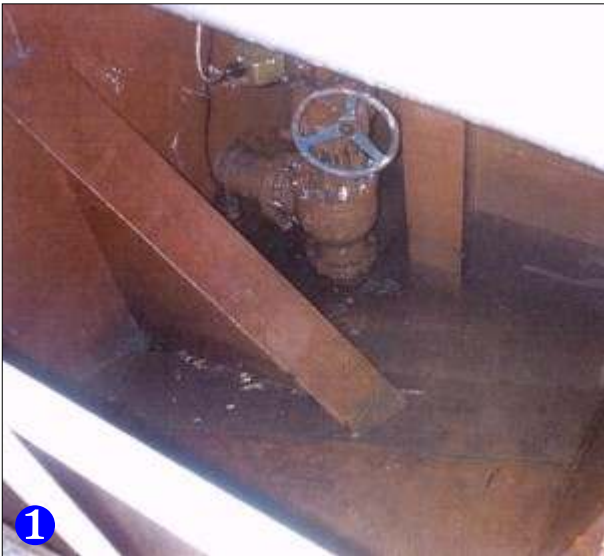
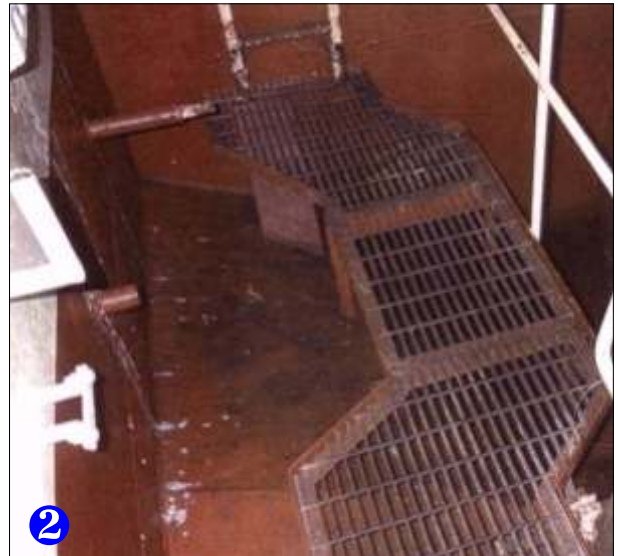
The bilge is in excellent shape with no corrosion or coatings failure noted

- 1 Forward Stb'd corner of the bilge. The sump area shows no sign of any deterioration
- 2 Due to continual damp conditions and minimum ventilation mold and mildew can be found
- 3 The Alocit Aquacoat is performing flawlessly in severe service
