ENVIROPEEL OFFSHORE

ENVIROPEEL
THERMOPLASTIC SYSTEMS

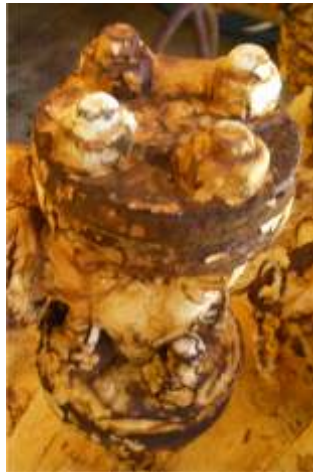
Reports from the North Sea indicate that many bolts are corroding before an installation has been commissioned, with cadmium plated bolts

failing after only a year and PTFE coated bolts failing within weeks.

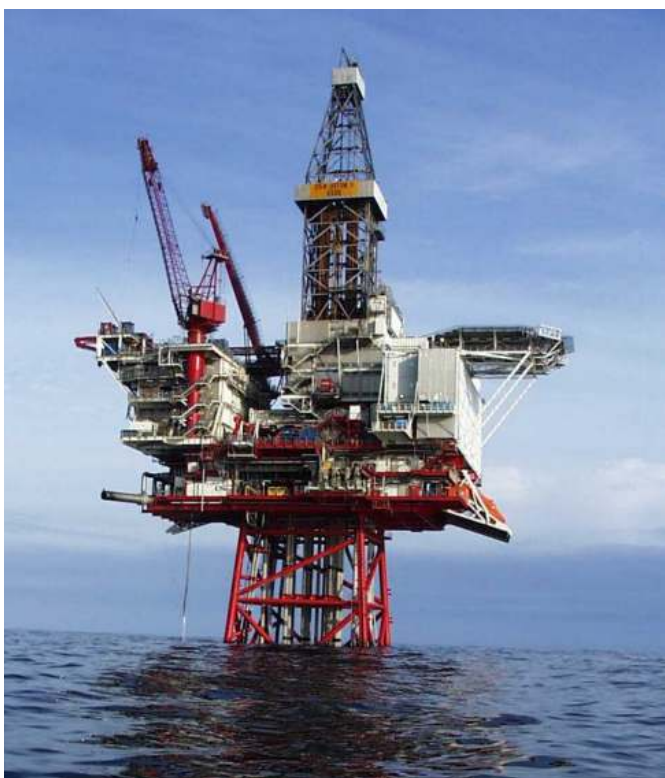
Enviropeel's own experience with offshore facilities has shown that it can offer protection to the whole system - bolts, nuts and flanges. Instead of seized nuts and rusting valves, every component is immediately ready for use, flanges free from the tell-tale staining of streaming rust - and from the danger of failure that such corrosion brings.

Applications in the North sea, the Middle East and in South-East Asia have shown that Enviropeel offers cost-effective and long-lasting solutions with a system that is flexible and reliable to use. Enviropeel equipment is specifically designed for use in zone 2 areas with either a 10 or 19 metre hose in order to reach the most inaccessible areas.

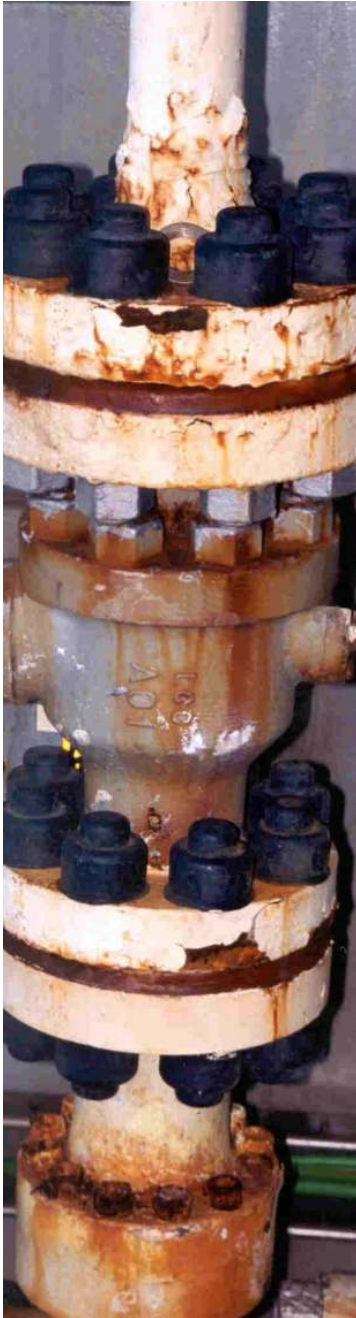
The flange assembly on the left shows all the problems typical of a bolted system. Aware of potential problems, engineers have used rubber caps to protect bolt heads and nuts but, typically, access is not possible to some areas because the flanges are too close together .

Attempts to use a caulking material have failed, as it is shrinking away from the surfaces, trapping moisture and making the situation worse. Rust streaming down the entire structure, accumulating at the base is making it very unlikely that the allen bolts at the bottom of the picture could ever be undone.

The complete breakdown of the coating on the flanges, and all the other problems outlined above, threaten the integrity of this entire assembly. Clearly, immediate remedial action is required, yet all previous attempts have failed. A new approach is needed, which is exactly what Enviropeel offers.

Nuts, bolts, flange faces and allen bolts would all be completely protected with one easy to apply coating. Difficulties of access, preventing the use of other methods, present no problem for Enviropeel - these areas could be just as easily protected as the rest of the assembly.

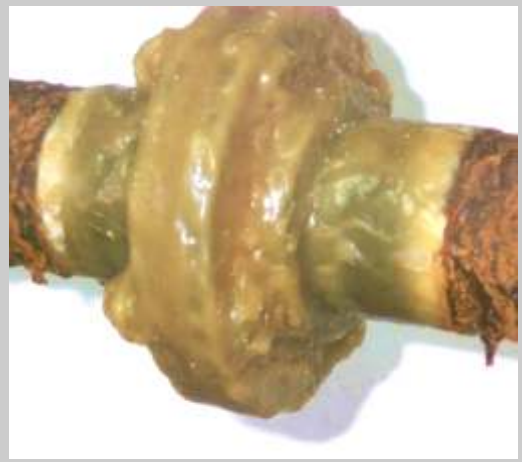
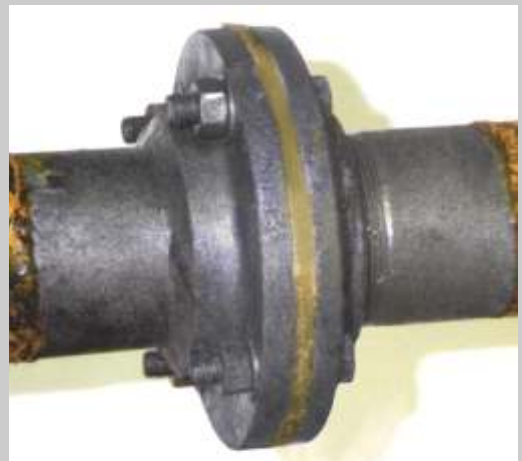
How well the Enviropeel system protects is demonstrated in these pictures from a 3000 hr ASTM B117 hot salt fog test. The unprotected mild steel test flange has severely rusted but, within the Enviropeel cocoon, no rusting has taken place. Nuts and bolts on the samples could be turned by hand, with no corrosion on any thread surfaces.

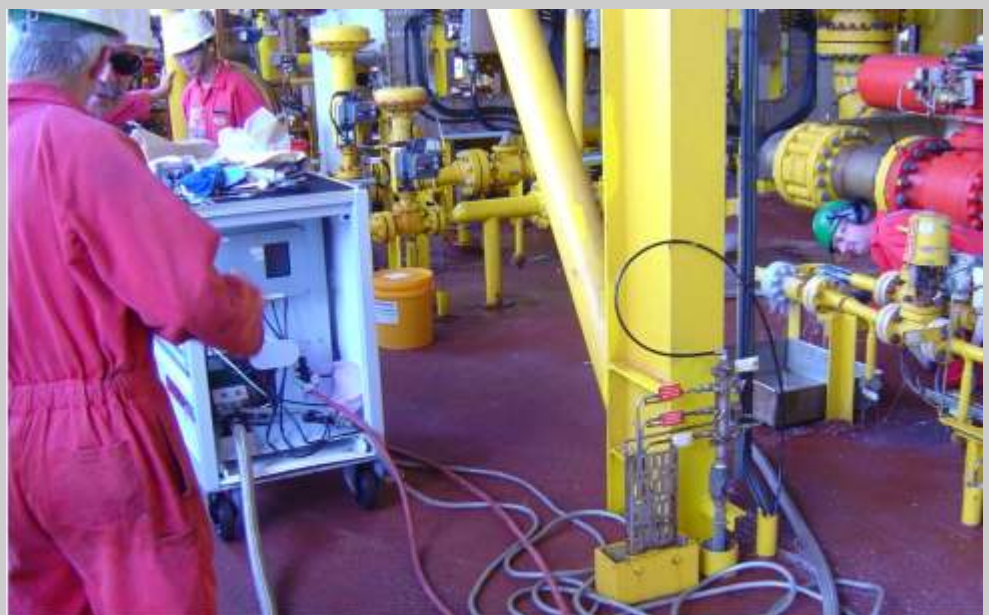
Enviropeel Zone 2 equipment in use for the Japan Vietnam Petroleum Co, CPC Oil Platform, Rong Dong Oilfield, South China Sea, Vietnamon which Enviropeel was applied to a series of flanges. The 10-metre zone-rated hose is clearly shown in this picture as material is applied to flanges on the platform. Hoses are manufactured up to 19 metres in length allowing wide access.

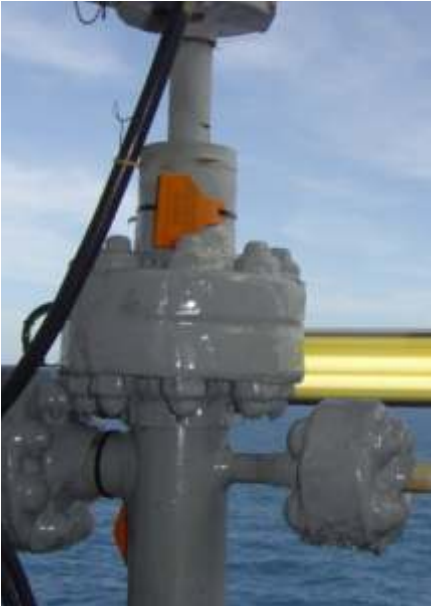
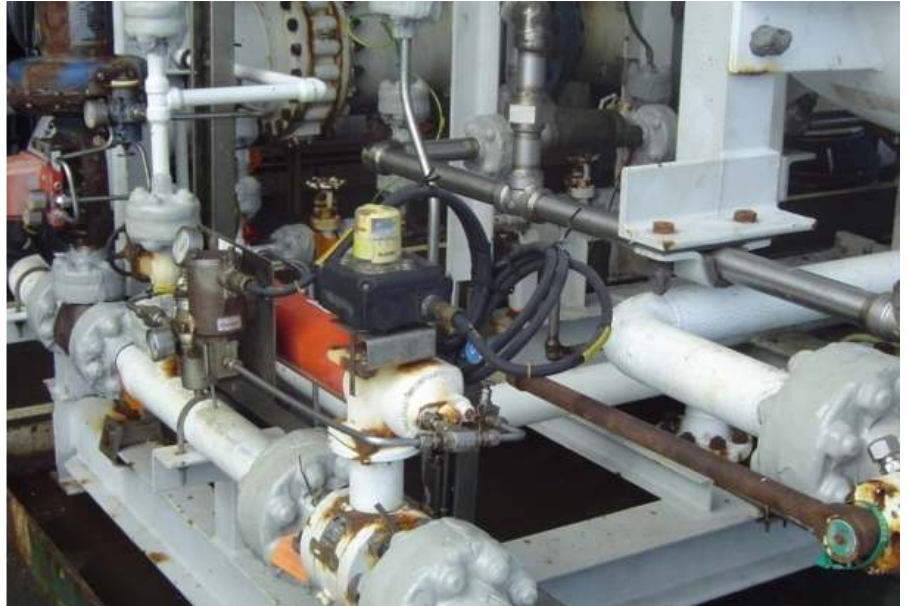
Above, left and right: Flanges on the Britannia platform in the North Sea, UK sector. Operated by Chevron and ConocoPhillips, the platform has undertaken a three year rolling programme of flange protection using Enviropeel for all flanges on 4" nominal bore pipes and below. For 2006, a full flange maintenance programme using Enviropeel was implemented

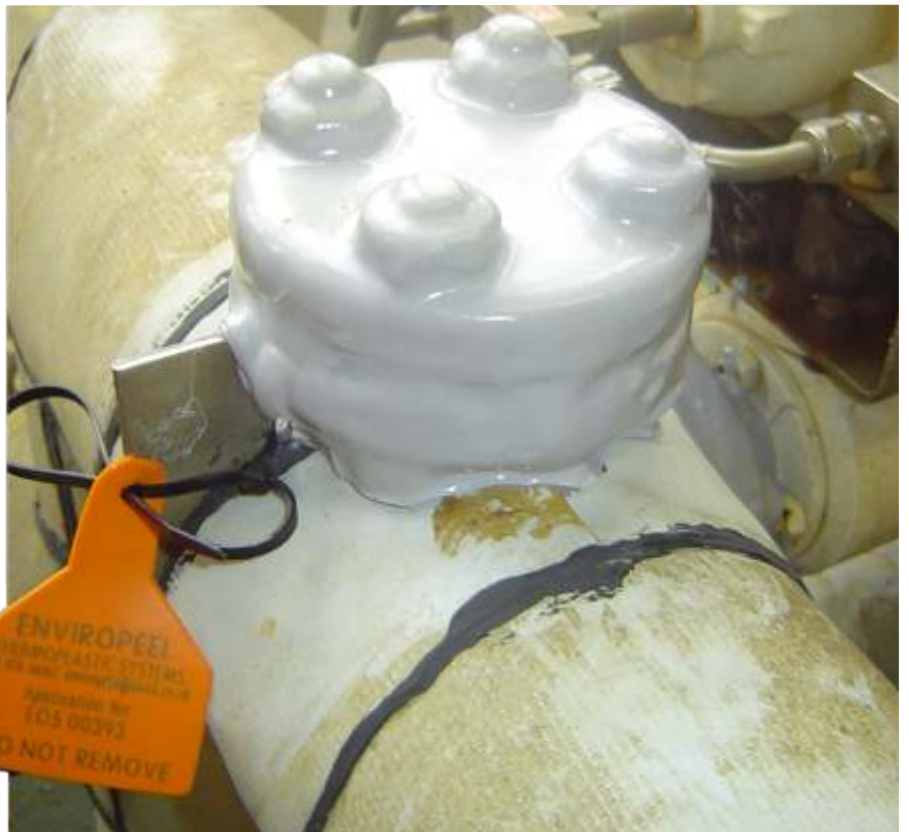
Right: As part of Enviropeel's ongoing development of asset maintenance services for its clients, a complete tagging and recording system has been implemented that identifies operator, time date and ambient conditions during each individual application.

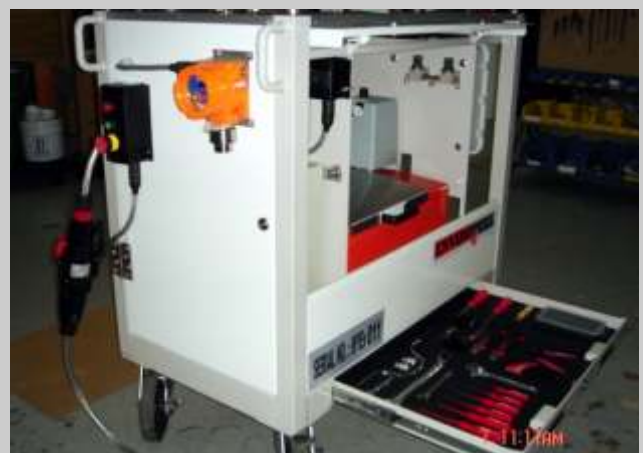
THE ZONE 2 UNIT

The applicator consists of a heating and pumping unit, an ATEX certified temperature-controlled hose and spray gun, all constantly controlled and monitored by the inbuilt microprocessor. All components are housed in a purpose-built mobile trolley and protected by a gas detection system, incorporating EXD electrical enclosures and an EX-rated Emergency Stop Station. It is DNV certified for use within a flammable atmosphere with ATEX and EXD components and a safety system that is designed to isolate the entire unit if any potential risk is detected.
