WHARF CONTAINER CRANE

A major Australian stevedoring company was looking for a solution to the problem of corrosion on the cleats and pigtails of their aging mobile portainer crane servicing the Fremantle Port. Of paramount concern to the operators was the potential hazard to wharf workers below if parts were to break free. Enviropeel was applied to prevent corrosion damage and secure the components to the crane platform and jib.

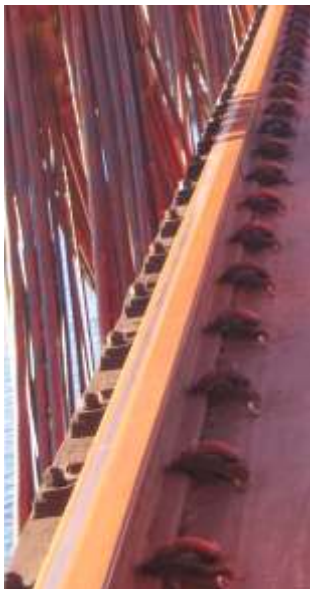
The cleats and pigtails securing the rails on the crane platform suffered severe corrosion caused by the marine environment and exposure to high winds, rain and extreme variations in temperature. The corrosion made them prone to breaking free and created a falling debris hazard for personnel working below.

*Above: A view of the Fremantle Port Portainer Crane
Left: A length of track on the crane platform showing the corroded cleats and pigtails*

The Enviropeel coating was essential to stop corrosion and prevent separation. For extra security an additional 'strip' was applied to link the outside cleats to each other. Surface preparation was minimal, requiring no more than a brush down of loose material and dirt. The elongated bolt holes on the cleats and the irregular curved shape of the pigtails allowed the Enviropeel to flow beneath the nuts and around the pigtails thereby 'locking' the material in place, pull checks on the set Enviropeel confirmed the encapsulation of the material with the substrate. In total 208 cleats on the outside of the rail and 104 pigtails were coated with Enviropeel to complete the work.

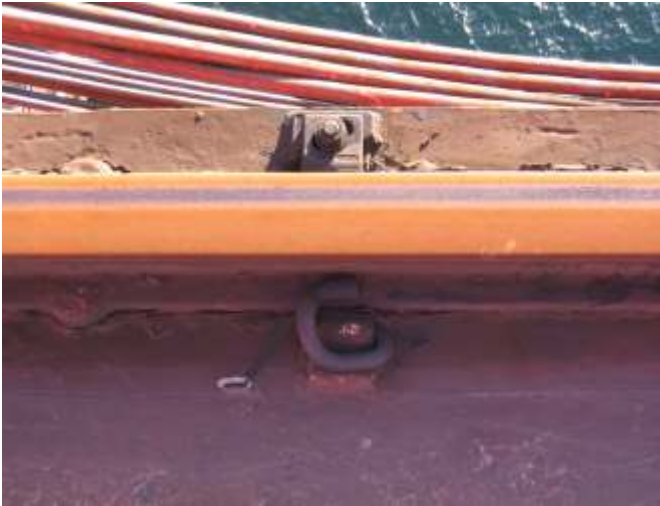
Top: A single cleat and pigtail prior to coating
 Above: Cleat and pigtail after being coated with Enviropeel

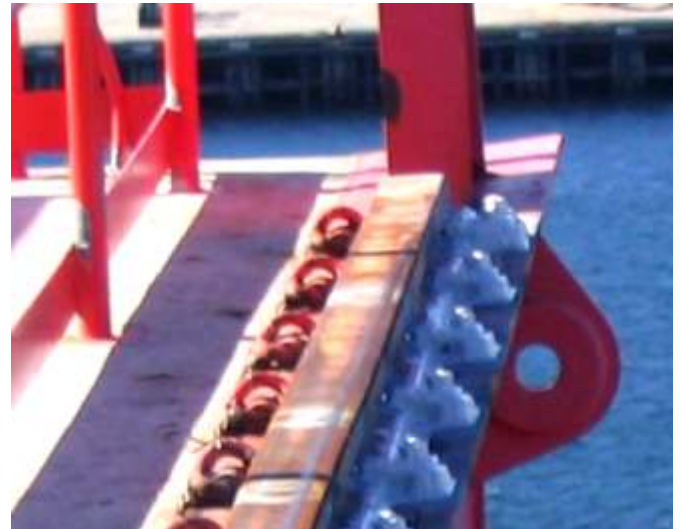
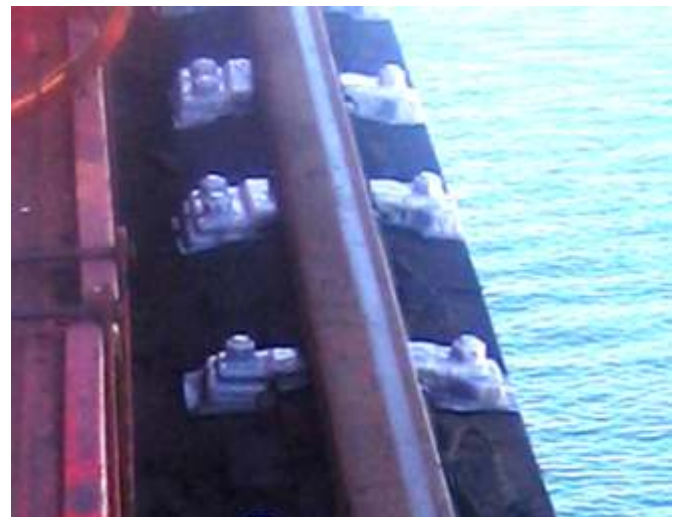
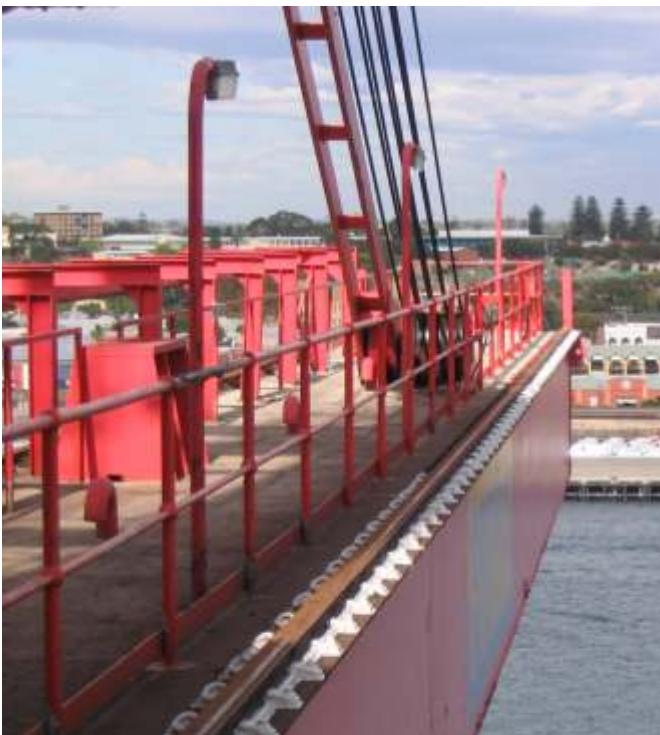
Right: A length of track on the jib showing coated cleats linked with Enviropeel to improve security
 Below Right: Views of Enviropeel coated cleats

Coating the cleats and pigtails on this aging crane with Enviropeel has solved two problems for the operators. All further corrosion has been prevented by the anti-corrosion inhibitors within the Enviropeel and the safety hazard to personnel from falling debris has been eliminated. This was a cost-effective option compared with the need to decommission the crane before the expected 2007 schedule or having to replace all the cleats and pigtails.
