PIPELINE REPAIR

Project type:	Power station gas supply pipeline repair
Location:	Pasir Gudang, Johor, Malaysia
Description:	1.5 km gas pipeline 10" to 24" diameter pipe, flanges and valves
Area coated:	2950m ²
Coating system:	2 x 300 micron coats 28.15 1 x 50 micron PU topcoat Enviropeel encapsulation of bolted systems
Surface Prep:	Blasted SA2/2.5 and Power Tool ST2 50-100 micron profile

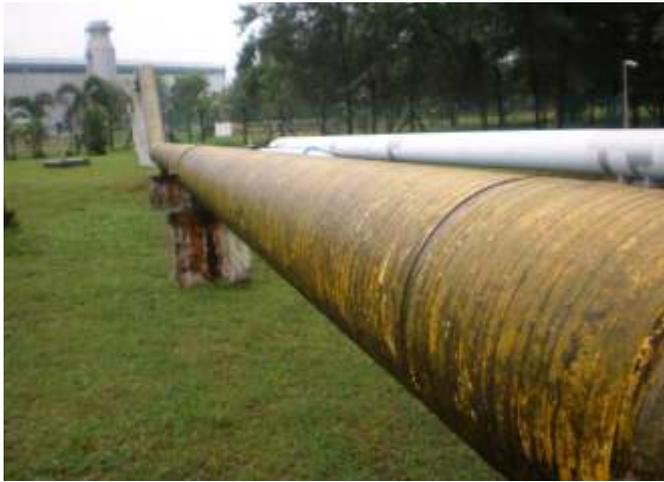
Gas pipelines at the TNB Power Station in Johor, Malaysia required repair and refurbishment as the polyethylene tape wrap system was failing. Penetration of the wrapping system entrapped moisture causing rapid spread of corrosion throughout the 1.5 km of pipe. Stagnant, permanently wet conditions such as those created within failed wrapping systems creates pitting corrosion which can lead to significant reductions in metal thickness and threaten pipeline integrity.

Above: the tape-wrap system has become a threat to the pipeline instead of protecting it. Rust products streaming from within the coating have stained the concrete supports.

First the failing wrap was removed, then surface preparation using a combination of blasting and power tools was undertaken. Two coats of Alocit 28.15 were carefully applied, with particular attention to coverage within pitted areas. Finally a cosmetic coat of a compatible PU was used.
