Flange Joint Protection in the North Sea

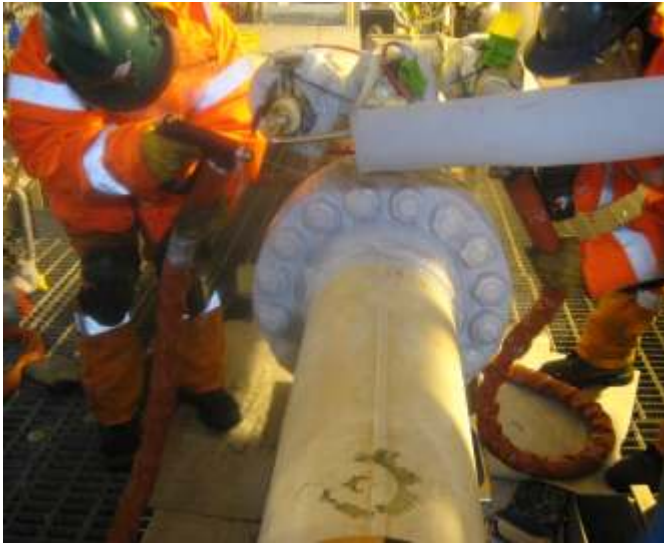
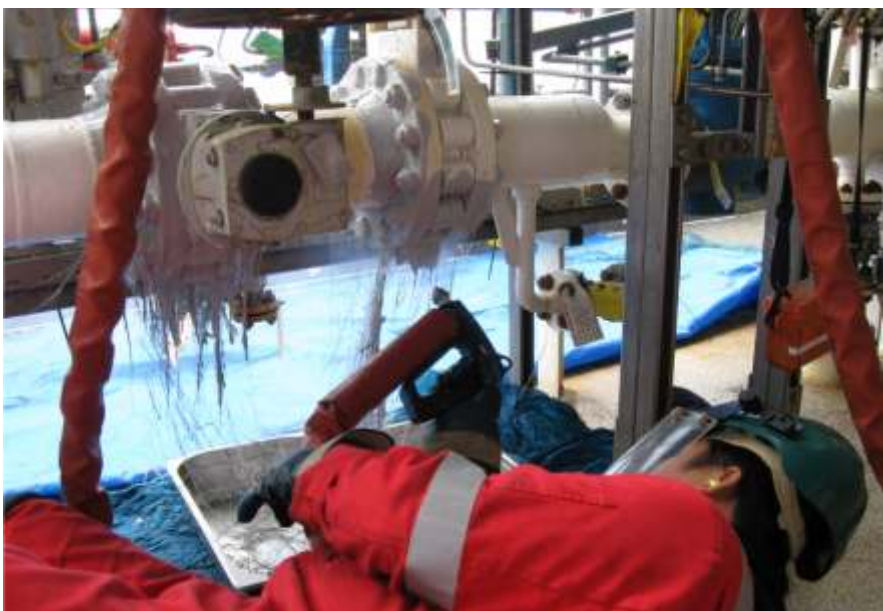
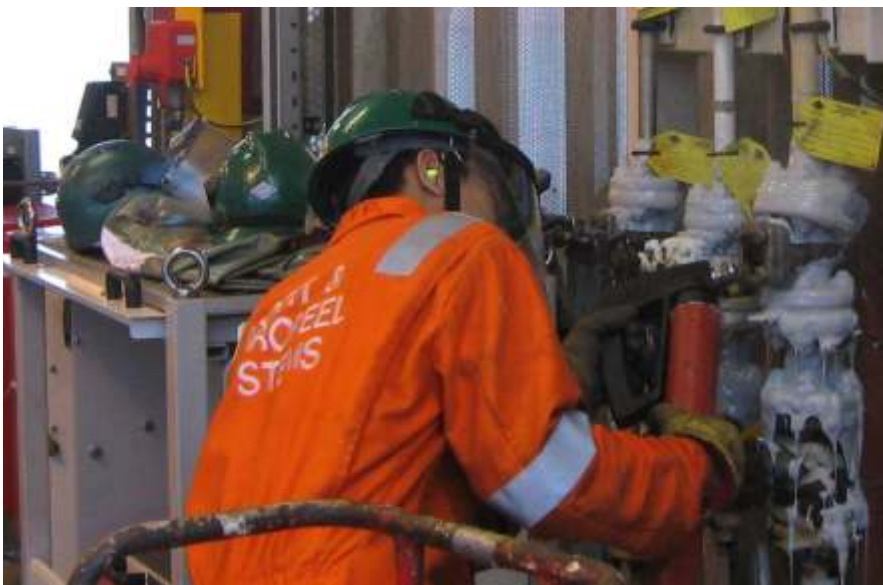
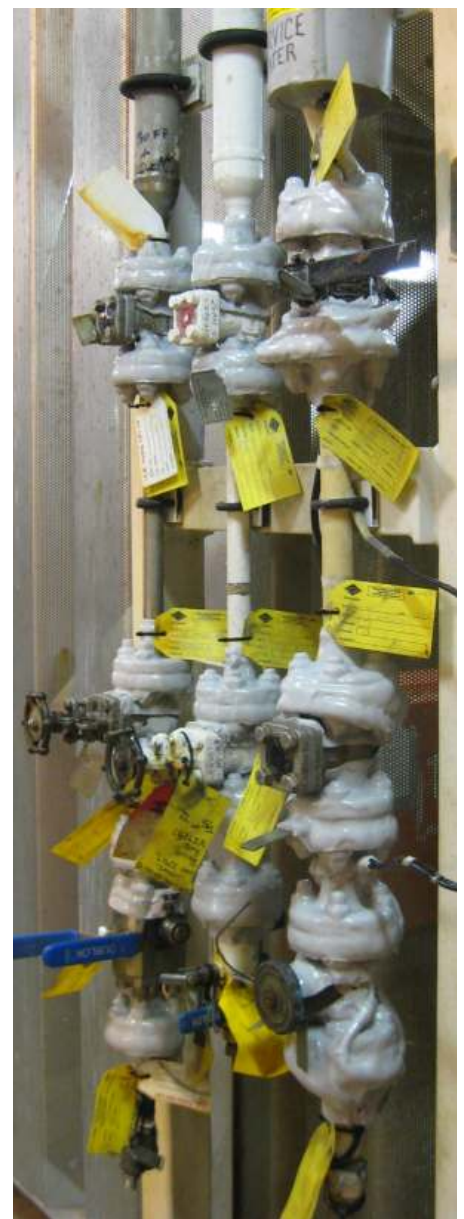
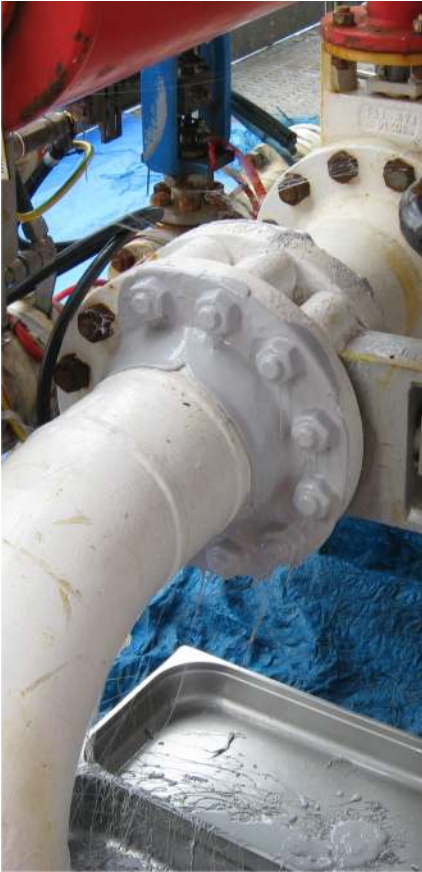
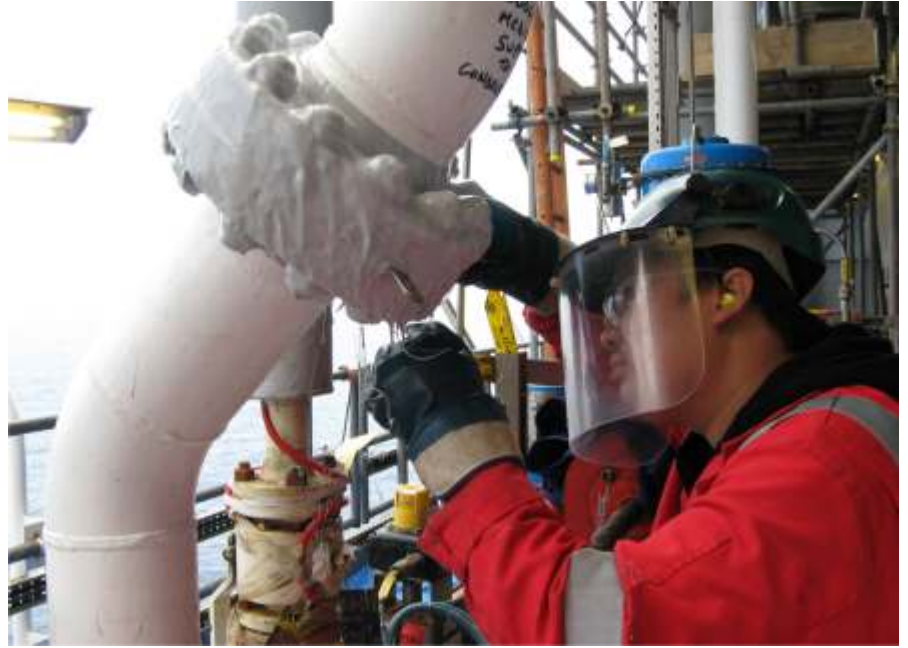
Left: two applicators work from either side of a large flange joint.

Below: during application a joint can look messy, but once both coats are completed and trimmed the joints look, and are, ready for the worst conditions the North Sea can throw at them!

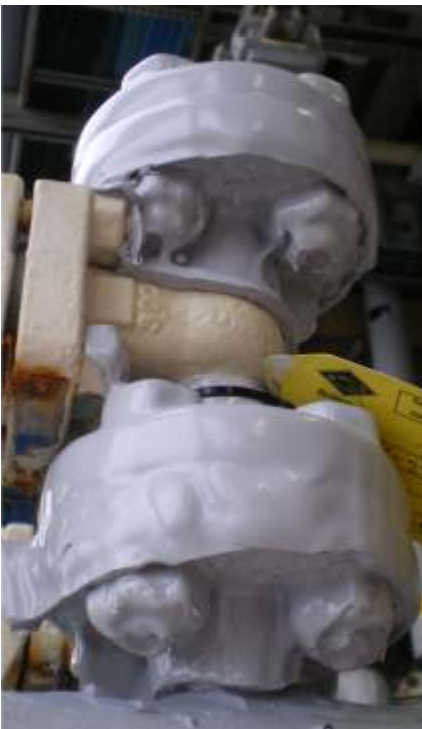
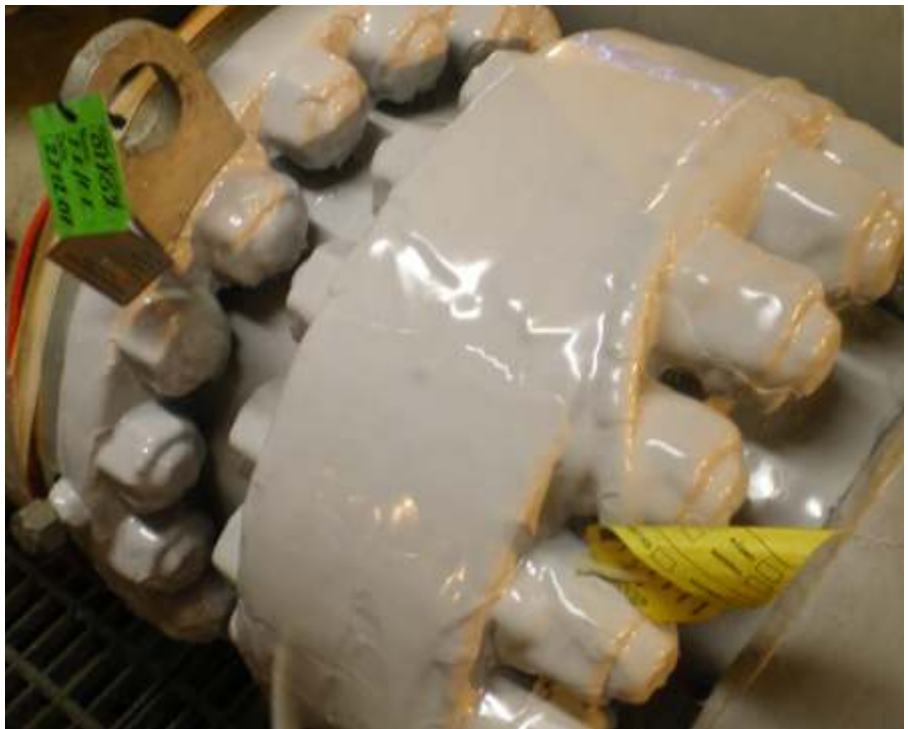
Application builds coats in succession, working from underneath, around the sides and finally above with two coats to provide maximum protection. The underside is the most difficult area to finish aesthetically but trimming between and after each coat ensures full protection. All trimmings and drips/spills are collected and recycled.

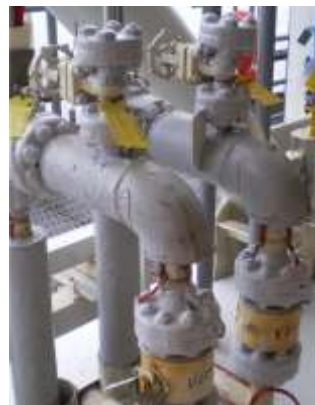
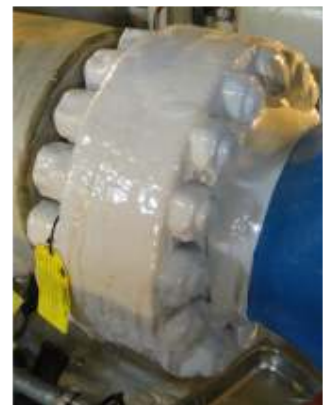
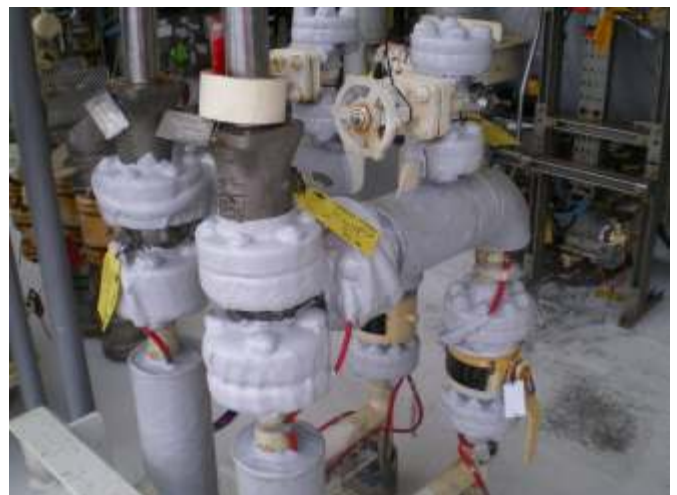
Right and above: A review of the finished applications shows the high standards maintained throughout the project.
