## CORROSION MECHANISMS

## **THE SIGNIFICANCE OF THE ATTACK**

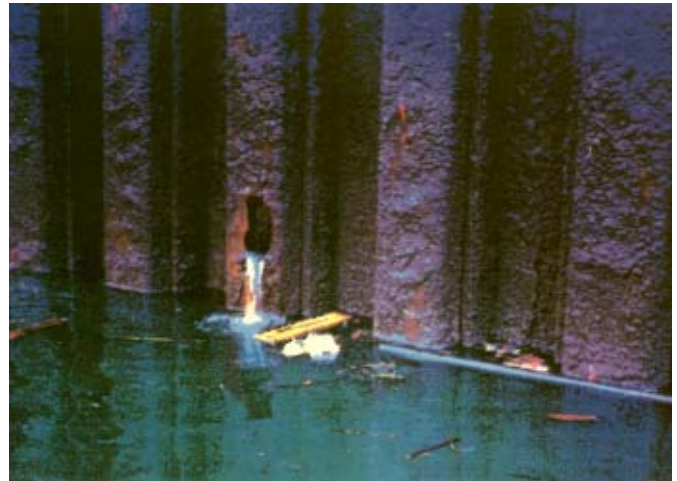
The first signs of accelerated corrosion on a marine structure may also be the last. Once the surface behind a quay has subsided, for example, and hundreds of cubic metres of backfill have been deposited through large holes in the quay wall, the resulting structural instability and reduced navigable depth of the quayside would mean total reconstruction of the quay or even total shutdown.

## Illustration: holes on piles

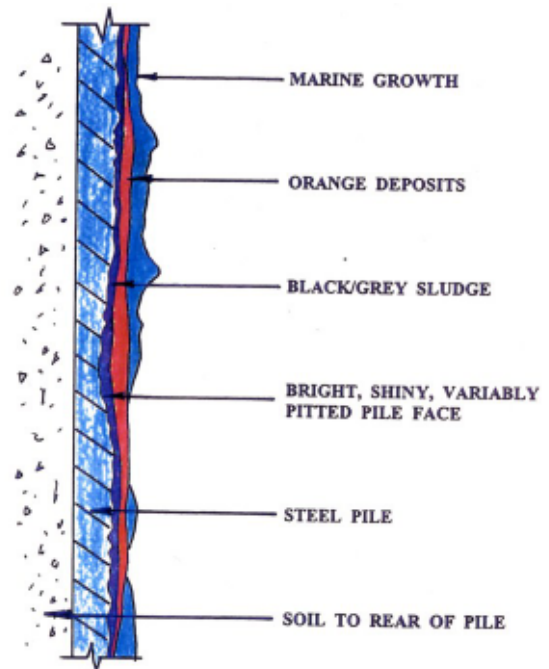
### Illustration: Sectional detail of the appearance of accelerated corrosion.

It is usually possible to spot early stage corrosion from a distance but the more advanced stages require closer inspection to become apparent. Occasionally it is the result of accelerated corrosion that is first to be noticed, usually when the ground surface behind a quay wall starts subsiding due to loss of soil through hidden corrosion holes, or on the first occasion that large holes in piles suddenly become manifestly clear.
