Although commonly referred to as Accelerated Low Water Corrosion, ALWC can occur in areas away from the low water band and be caused by different individual or combinations of corrosion mechanism and may also be referred to simply as Accelerated or Concentrated Corrosion as well as Microbially influenced Corrosion (MIC).

## CORROSION MECHANISMS

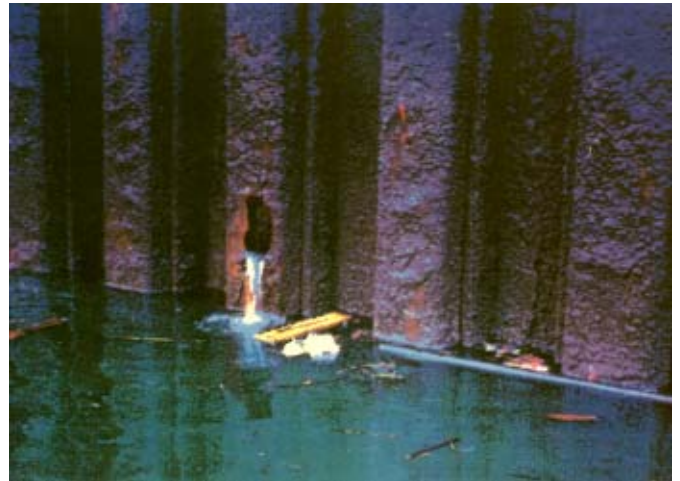
## Illustration: holes on piles

The first signs of accelerated corrosion on a marine structure may also be the last. Once the surface behind a quay has subsided, for example, and hundreds of cubic metres of backfill have been deposited through large holes in the quay wall, the resulting structural instability and reduced navigable depth of the quayside would mean total reconstruction of the quay or even total shutdown.

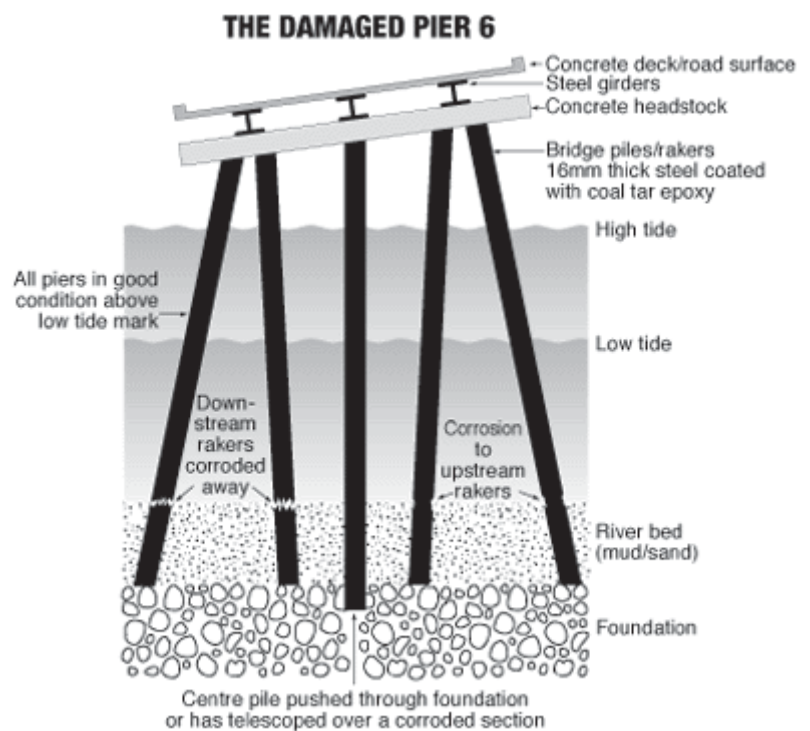
### Illustration: Diagram of bridge failure

1. Sulphate Reducing Bacteria: Extensive colonies with mushroom-like heads were found on the piles, particularly on bare steel sections. The bacteria produced a sulphide slime, which attacked the steel and resulted in large pit corrosion.

2. Sulphide Mud: A significant removal of mud from the bridge site had occurred over 30 years, exposing sulphides. Oxidation then produced a weak sulphuric acid, which attacked the piles.
3. Abrasion: Water velocity reaching 3.5 metres per second continuously removed corrosion as it formed.
4. Galvanic action within piles: Friction between weld metal and parent metal.
5. Galvanic action between pile groups: Corrosion in electrolyte where coatings have degraded from steel.

The Adelaide River Bridge was constructed in 1966/67 as a one-lane bridge, although all the sub-structure to support two lanes was designed and built at the same time. The bridge was upgraded to two lanes in 1972/73. The bridge consists of a super structure of a concrete deck sitting atop three steel beams. These beams in turn sit on nine piers spaced at intervals of about 18.3m across the river. Each pier contains five piles, a straight pile in the centre with two "raker" piles on each side. These piles consist of 16mm thick octagonal steel, some filled with concrete to varying levels as demanded in the plans. They are coated with coal tar epoxy.

An engineering report, investigating the collapse of a Northern Territory bridge, found that two piles of the Adelaide River Bridge were completely corroded through the base. This was caused by a number of factors, including a sulphate reducing bacteria which had attacked the steel and which had not previously been known to exist in tropical conditions.

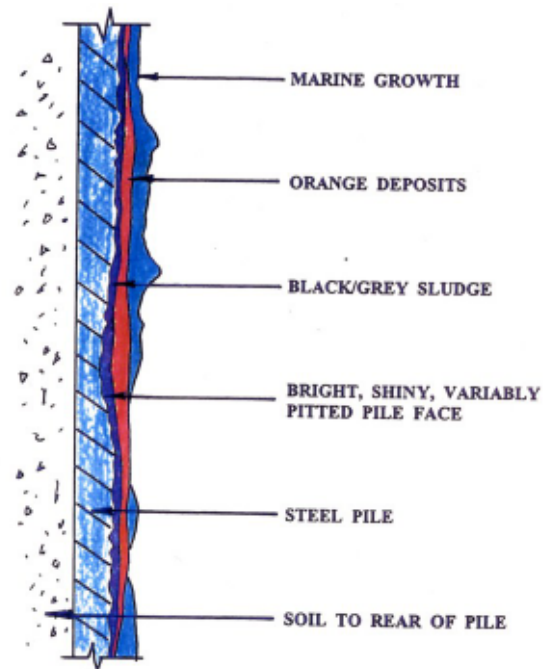
### Illustration: Sectional detail of the appearance of accelerated corrosion.

Accelerated corrosion can exist in quite an advanced state of perforation of the steel, or even as larger holes but, as above, can remain disguised due to overlying marine growth. Even if removal and cleaning does not reveal perforations a good hit with a hand-pick may go right through the apparently sound steel surface (although deliberate perforation is not recommended as even the smallest holes can complicate the repair process later on).

It is usually possible to spot early stage corrosion from a distance but the more advanced stages require closer inspection to become apparent. Occasionally it is the result of accelerated corrosion that is first to be noticed, usually when the ground surface behind a quay wall starts subsiding due to loss of soil through hidden corrosion holes, or on the first occasion that large holes in piles suddenly become manifestly clear.

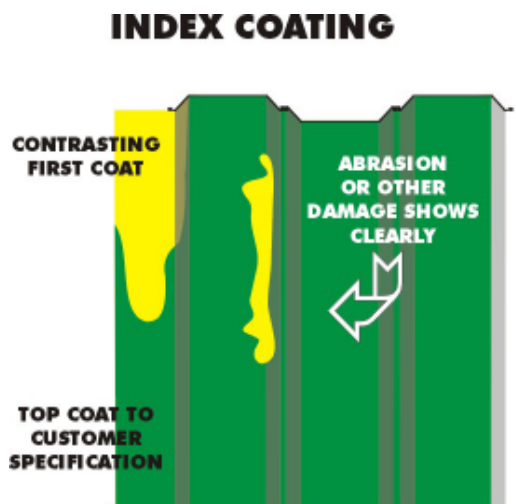
To facilitate maintenance programmes Alocit recommends using a colour index system when coating. By using contrasting colours for the first coat (at least two coats are always required to minimise the possibility of pin-holes), wear in the top coat can be detected before coating integrity is lost. Using this system also helps engineers and contractors follow the correct coating sequence, critical to the long-term success of protective coating systems.

**Illustration: Index coating provides an easily visible warning of damage to the top coat**

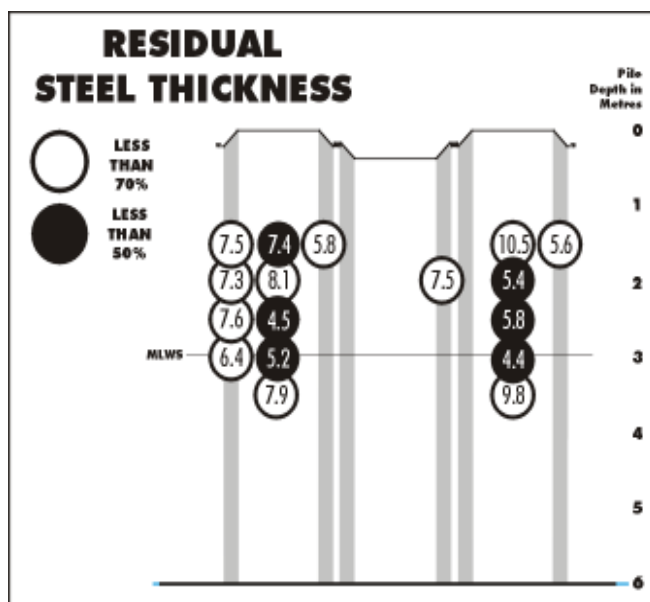
At Aberdeen Harbour surveys have shown (as the chart on the right illustrates) that corrosion of steel piles is taking place more quickly in some areas than others. In recognition of this fact an ongoing programme of survey has been undertaken. This has already resulted in repair works, including hydro-blasting, weld repairs and application of a two-coat black/grey index coded coating system where 15mm thick steel sheet piles had become holed. With 5 km of steel piled marine structures, Aberdeen is only too aware of the potential threat to its infrastructure. Its enlightened approach to surveying and planned maintenance has recently brought to light corrosion damage that, had not repairs been undertaken, would almost certainly have necessitated reconstruction of the berth within 3 or 4 years – a far more costly and disruptive alternative to its careful approach.

Illustration: Chart shows variation in pile thickness due to corrosion

Regular maintenance included inspection and painting of the piles above the low tide mark, where any corrosion was expected to occur, due to contact with oxygen and salt water. Gradual erosion of the piers below the water line was accounted for in the bridge design. The expected loss in a tropical corrosive atmosphere was 8mm per 100 years, providing a lifespan of over 100 years for the bridge. The fact that the life of the affected piles was reduced by 75% may not be entirely attributable to the Sulphate Reducing Bacteria, but it was clearly a significant factor. It is ironic that the inspection regime took into account the effects of corrosion but had expected the majority to occur above the water line. Steel piles are designed to hold things up, hold things back, or do both. The ability of each pile to do this is directly related to the thickness of steel and its shape. Any reduction of thickness results in a loss of strength. If enough steel is lost at any particular location, say 50%; the ability of the affected pile to work as designed becomes critical. The practical outcome of this could involve placing restrictions on use. If more steel is lost the outcome could be structural failure and complete loss of the facility. *Illustration: Survey of Pile thickness on Aberdeen Harbour*

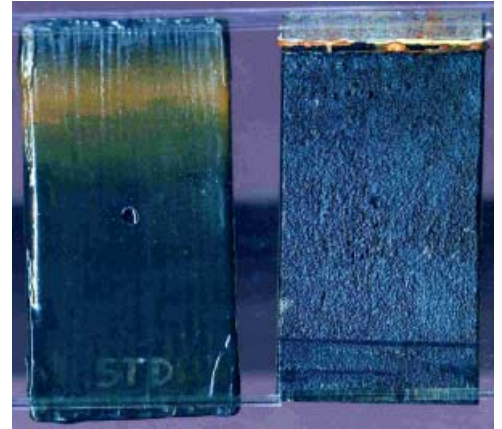
1. That steel control panels representing areas of no coating presence are subject to severe corrosion/encrustation/Biofilm Generation.

**Illustration: Early samples from the test programme. The uncoated sample on the right shows significant deterioration**

The company’s positive experiences led, in 1998, to field tests in Northern Ireland on a site where ALWC was causing extensive damage to the harbour at Killybegs. Blasting and coating to piles underwater was undertaken, using divers to apply the coating. These areas remain in perfect condition.
