ENVIROPEEL OFFSHORE

ENVIROPEEL
THERMOPLASTIC SYSTEMS

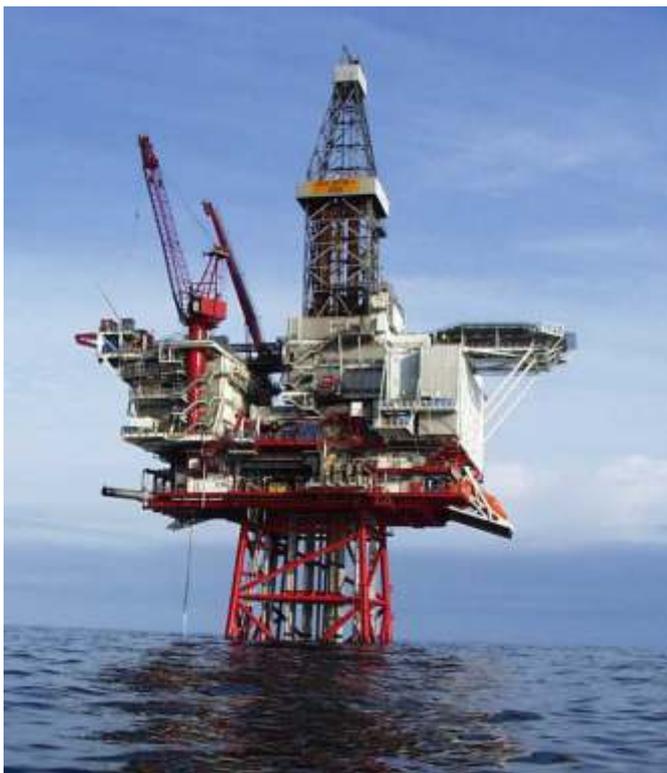
Enviropeel equipment is specifically designed for use in Zone 2 areas with either a 10 or 19-metre hose, allowing it to reach the most inaccessible areas.

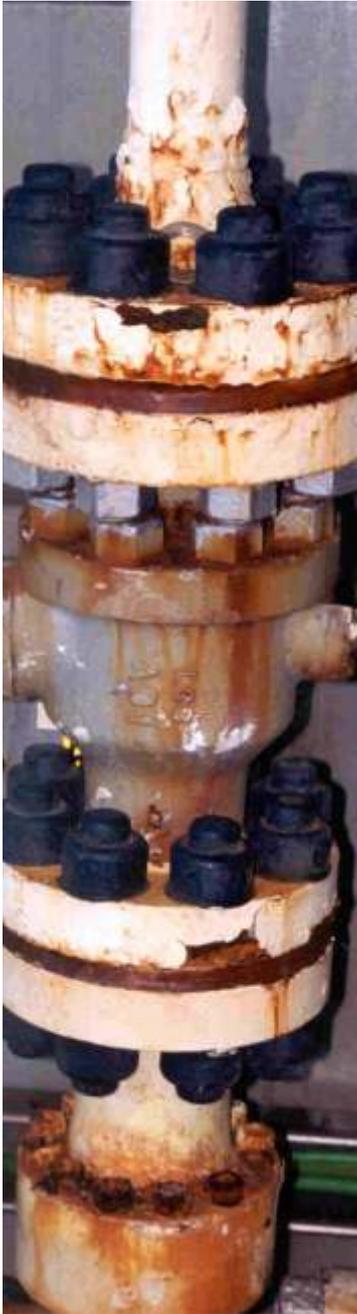
The flange assembly on the left shows all the problems typical of a bolted system. Aware of potential problems, engineers have used rubber caps to protect bolt heads and nuts but, typically, access is not possible to some areas because the flanges are too close together .

Attempts to use a caulking material have failed, as it is shrinking away from the surfaces, trapping moisture and making the situation worse. Rust streaming down the entire structure, accumulating at the base is making it very unlikely that the allen bolts at the bottom of the picture could ever be undone.

The complete breakdown of the coating on the flanges, and all the other problems outlined above, threaten the integrity of this entire assembly. Clearly, immediate remedial action is required, yet all previous attempts have failed. A new approach is needed, which is exactly what Enviropeel offers.

Nuts, bolts, flange faces and allen bolts would all be completely protected with one easy to apply coating. Difficulties of access, preventing the use of other methods, present no problem for Enviropeel - these areas could be just as easily protected as the rest of the assembly.

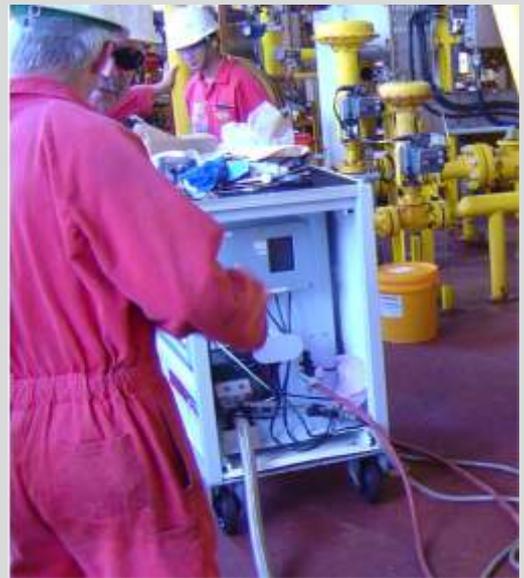
Above: Enviropeel Zone 2 equipment being prepared for use offshore in Vietnam.

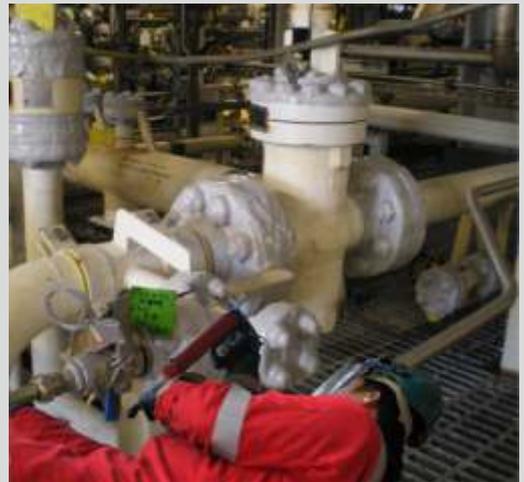
Below: an Enviropeel application engineer gets down to work on an offshore substrate.

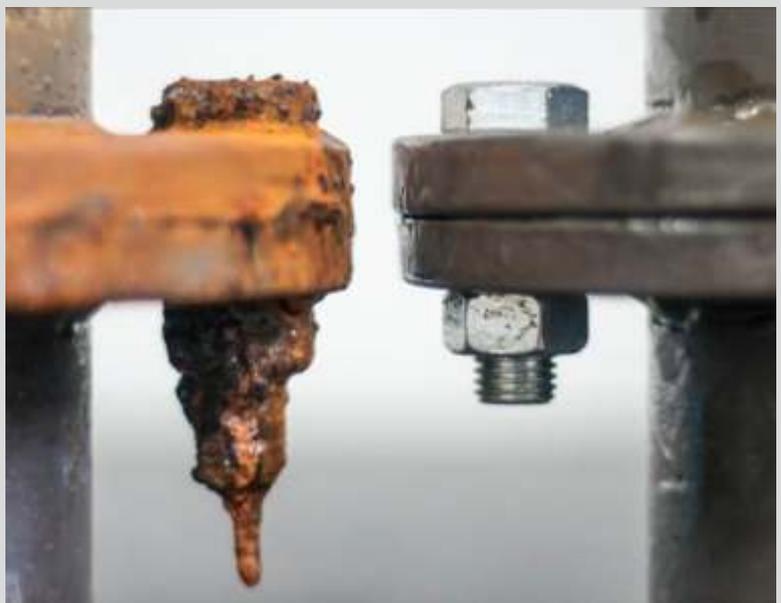
10,000 HOUR ASTM HOT SALT FOG TEST

How well the Enviropeel system protects is demonstrated in these pictures from a recently completed 10,000 hr ASTM B117 hot salt fog test - ten times the average length of most hot salt fog testing. The contrast between the unprotected control and the Enviropeel-protected test piece is stark. On the control piece, the coating has failed and the bolt is severely rusted but, within the Enviropeel cocoon, no rusting has taken place. Nuts and bolts on the protected sample could be turned by hand, with no corrosion on any thread or flange surfaces.

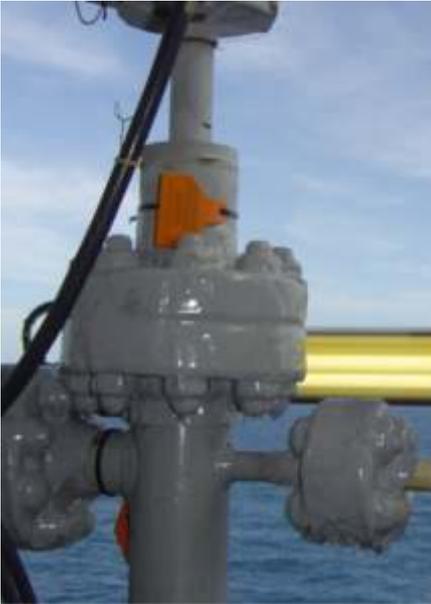
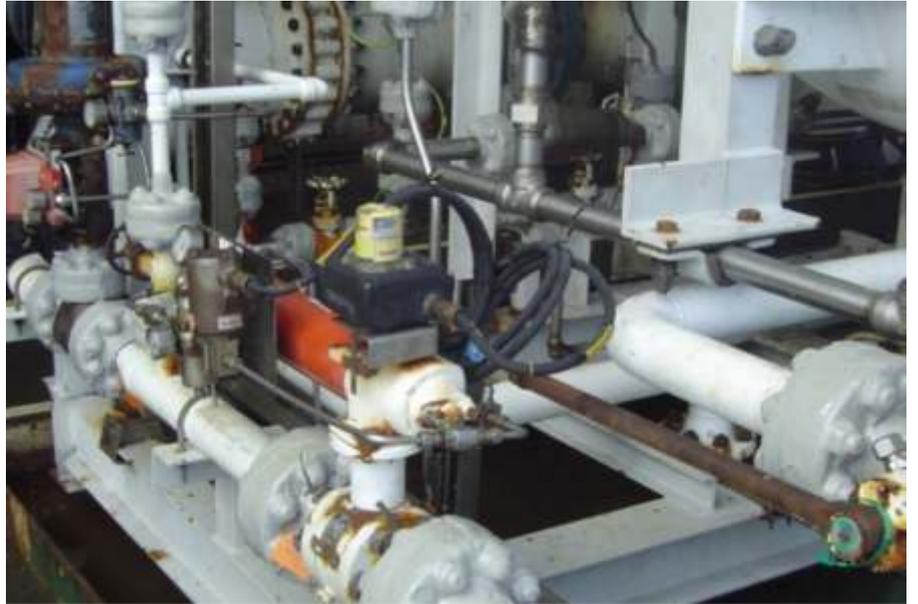
Above, left and right: Flanges in the North Sea, UK sector. The platform initially undertook a pilot programme for all flanges on 4" nominal bore pipes. Subsequently, a full flange maintenance programme using Enviropeel was implemented.

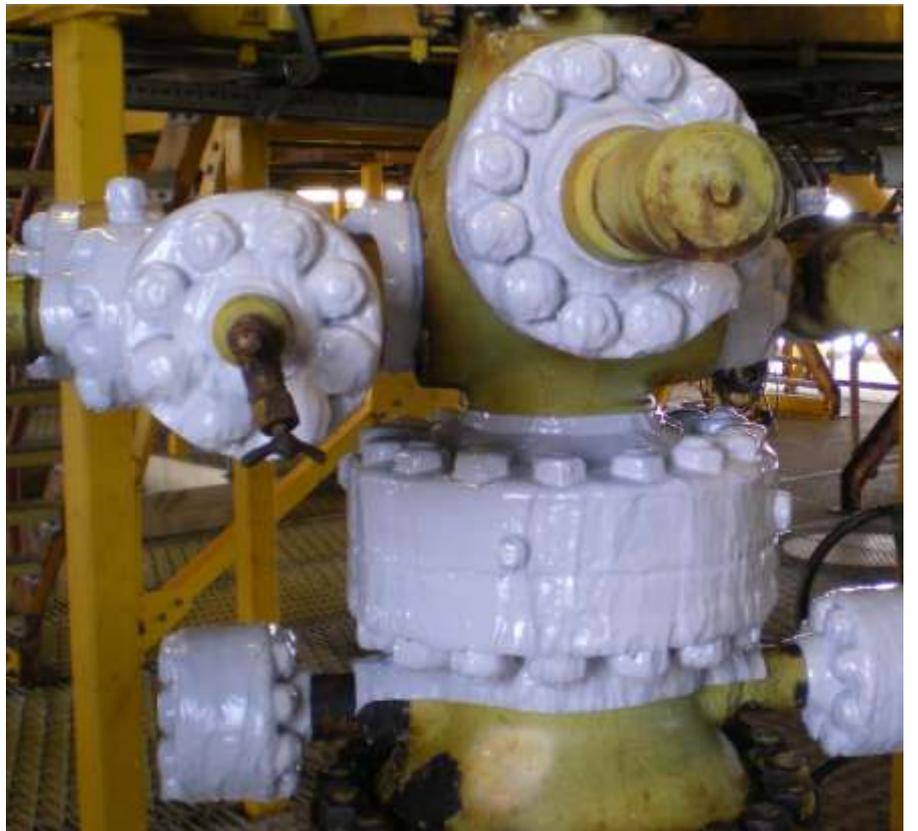
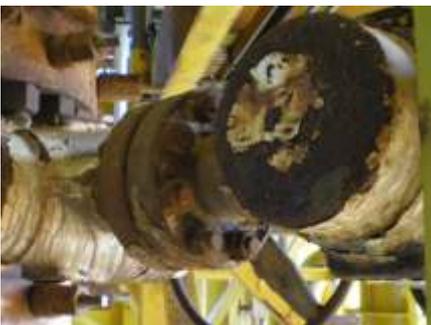
Below and right: Enviropeel can be used to remedy quite extreme cases of neglect.

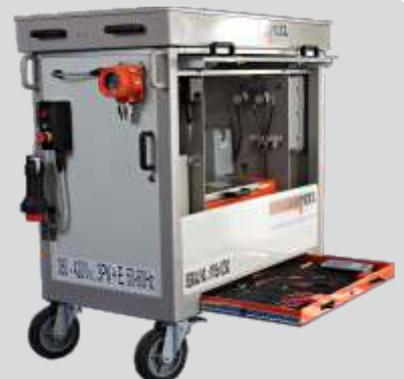
THE ZONE 2 APPLICATION UNIT

Every Enviropeel unit is custom-built to the highest standards. The Zone 2 applicator, like the base units, can be supplied in a variety of capacities and hose lengths. The equipment consists of a heating and pumping unit fitted with an ATEX certified temperature-controlled hose and a spray gun. All components are housed in a purpose-built mobile trolley and protected by a gas detection system, incorporating EXD electrical enclosures and an Emergency Stop Station. They are DNV certified for use within a flammable atmosphere and a safety system that is designed to isolate the entire unit if any potential risk is detected.

Above: The CA 18 Z2 unit
Left: The MA-Ex 25 unit
