# SPLASH ZONE - TURKEY

Momentum Engineering called in Alocit Systems when problems arose with the original coating on a Turkish Petroleum offshore gas platform in the Sea of Marmara, Turkey. Momentum, specialists in offshore oil and gas rig design and installation, needed a tough, environmentally friendly coating that could be applied in the splash zone on areas of the superstructure that were not adequately covered by the polyurethane top coat.

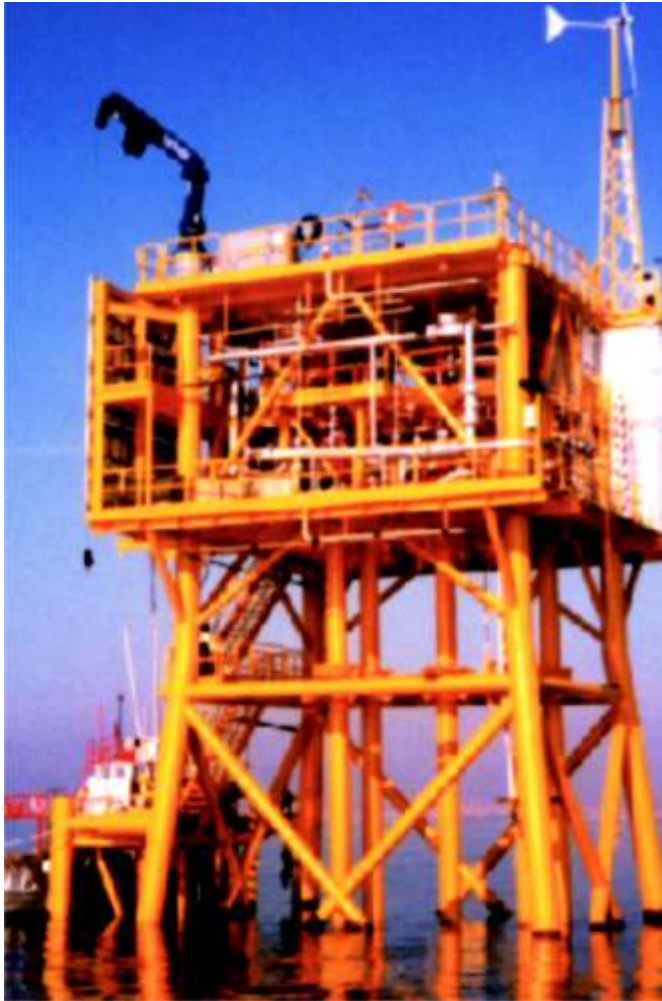
The superstructure had been brought overland in sections and coated before installation in approximately 43 metres of water. When the main platform was submerged the mud-mat over which it was situated proved to be significantly deeper than expected. The 1.5 metre depth of the mud-mat meant that an area, from a depth of 0.75 metres to a 0.5 metre splash zone, required a coating to match the yellow top coat on exposed areas of legs and struts painted black because they had been expected to be below the surface.

*Above: The small platform in its idyllic coastal setting. At the sea level, exposed areas of the legs and struts that should have been submerged can clearly be seen without the yellow polyurethane top coat.*

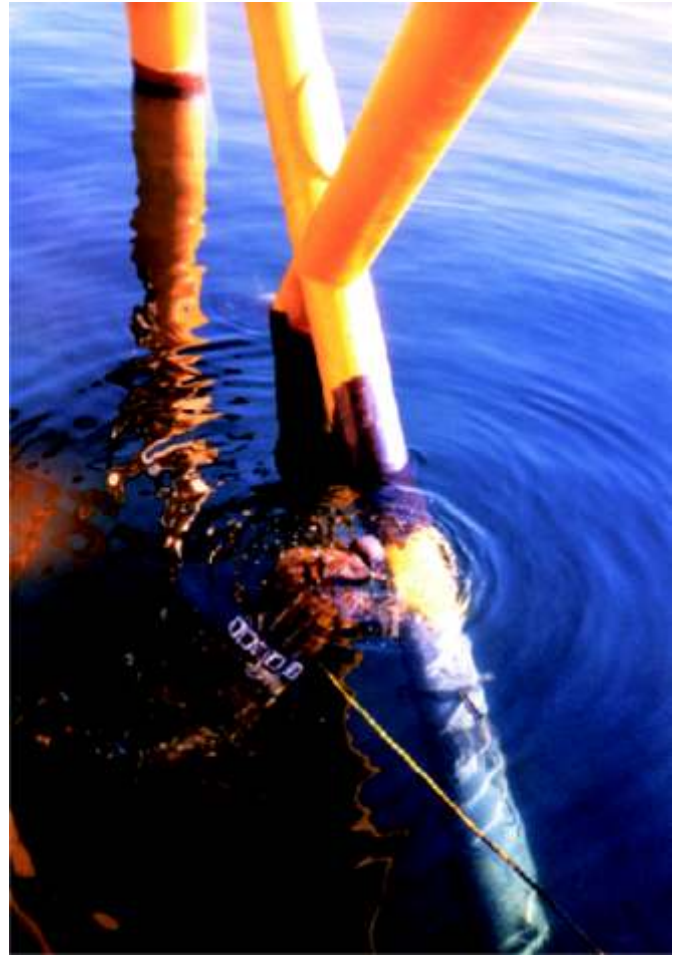
*Above: The coating is applied by hand brush straight from the tin. First, an index coating of black followed by a top coat tinted to match the original polyurethane.*

Following the cleaning operation, A two-coat index system of Alocit 28.15 was applied. The first was black in order both to define the area being coated and to provide an early warning of damage to the final tinted top coat.

tinted to match the customer's specifications and applied the same day, providing a cosmetic and hard wearing solution without any disruption to the normal operation of the facility.

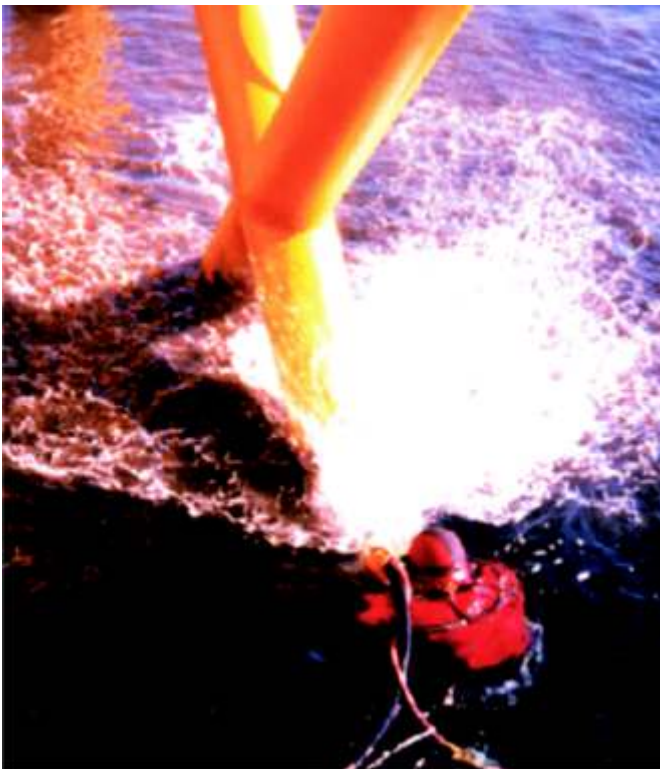
*Top left: A diver prepares the surface for coating using grit-blasting equipment.*

grit-blasting to remove marine growth and provide a surface profile for the Alocit System.

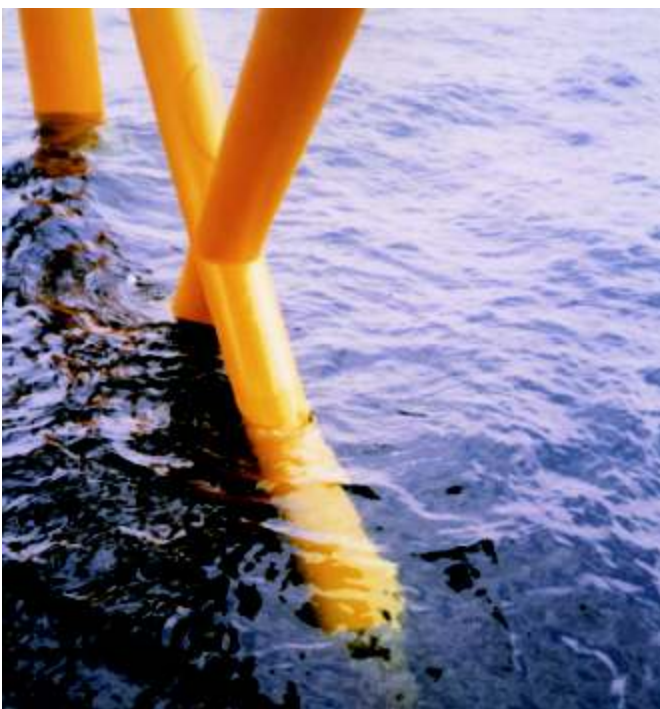
*Bottom left: The finished repair is indistinguishable from the rest of the structure.*

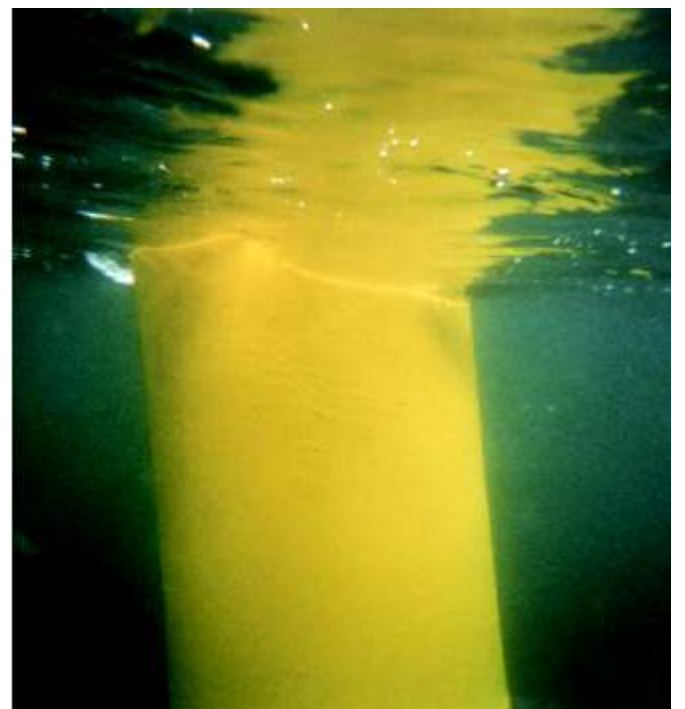
*Below: Underwater, the leg can be seen to be fully coated and protected.*
