# ENVIROPEEL OFFSHORE

**ENVIROPEEL**  
THERMOPLASTIC SYSTEMS

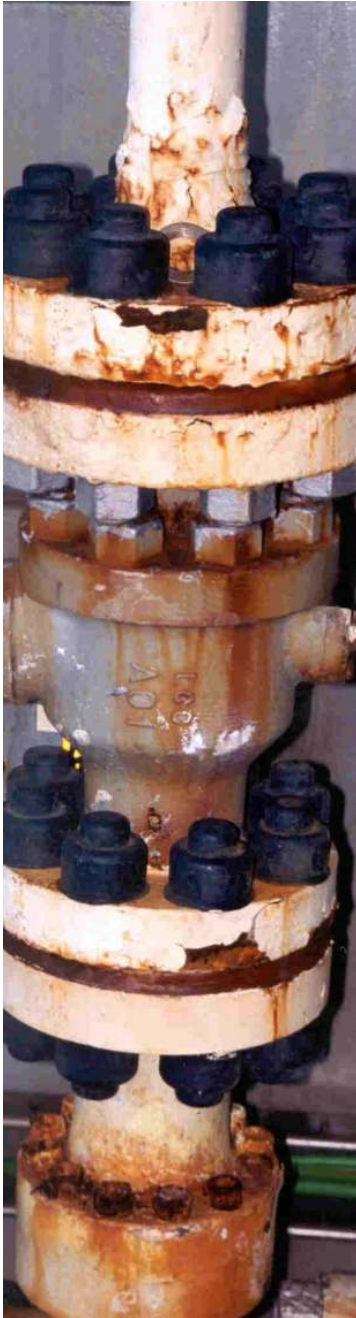
The flange assembly on the left shows all the problems typical of a bolted system. Aware of potential problems, engineers have used rubber caps to protect bolt heads and nuts but, typically, access is not possible to some areas because the flanges are too close together .

Attempts to use a caulking material have failed, as it is shrinking away from the surfaces, trapping moisture and making the situation worse. Rust streaming down the entire structure, accumulating at the base is making it very unlikely that the allen bolts at the bottom of the picture could ever be undone.

The complete breakdown of the coating on the flanges, and all the other problems outlined above, threaten the integrity of this entire assembly. Clearly, immediate remedial action is required, yet all previous attempts have failed. A new approach is needed, which is exactly what Enviropeel offers.

Nuts, bolts, flange faces and allen bolts would all be completely protected with one easy to apply coating. Difficulties of access, preventing the use of other methods, present no problem for Enviropeel - these areas could be just as easily protected as the rest of the assembly.

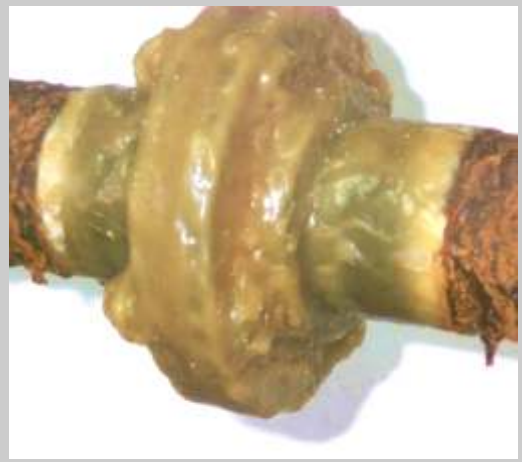
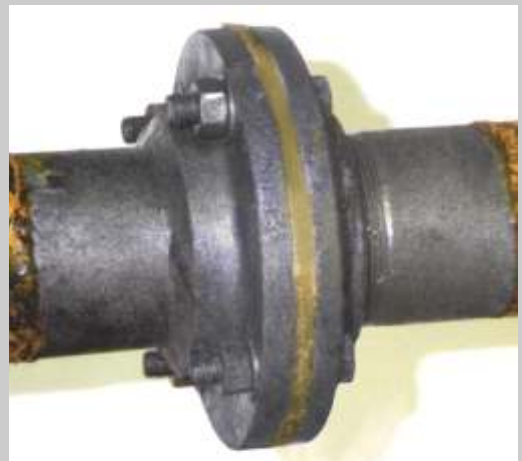
How well the Enviropeel system protects is demonstrated in these pictures from a 3000 hr ASTM B117 hot salt fog test. The unprotected mild steel test flange has severely rusted but, within the Enviropeel cocoon, no rusting has taken place. Nuts and bolts on the samples could be turned by hand, with no corrosion on any thread surfaces.

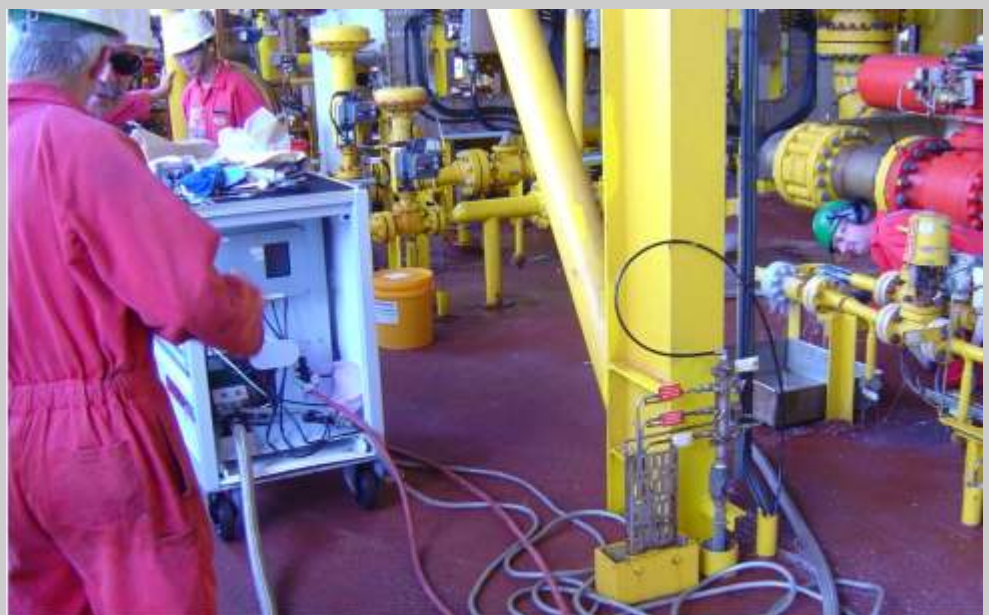
*Enviropeel Zone 2 equipment in use for the Japan Vietnam Petroleum Co, CPC Oil Platform, Rong Dong Oilfield, South China Sea, Vietnamon which Enviropeel was applied to a series of flanges. The 10-metre zone-rated hose is clearly shown in this picture as material is applied to flanges on the platform. Hoses are manufactured up to 19 metres in length allowing wide access.*

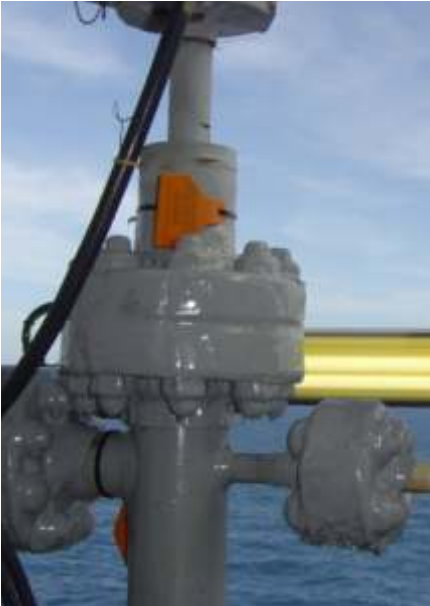
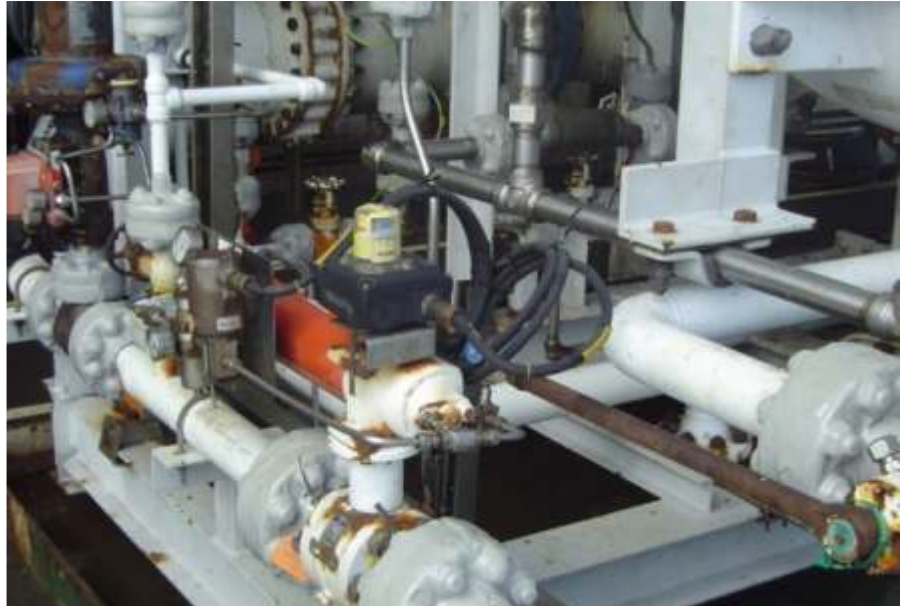
Above, left and right: Flanges on the Britannia platform in the North Sea, UK sector. Operated by Chevron and ConocoPhillips, the platform has undertaken a three year rolling programme of flange protection using Enviropeel for all flanges on 4" nominal bore pipes and below. For 2006, a full flange maintenance programme using Enviropeel was implemented

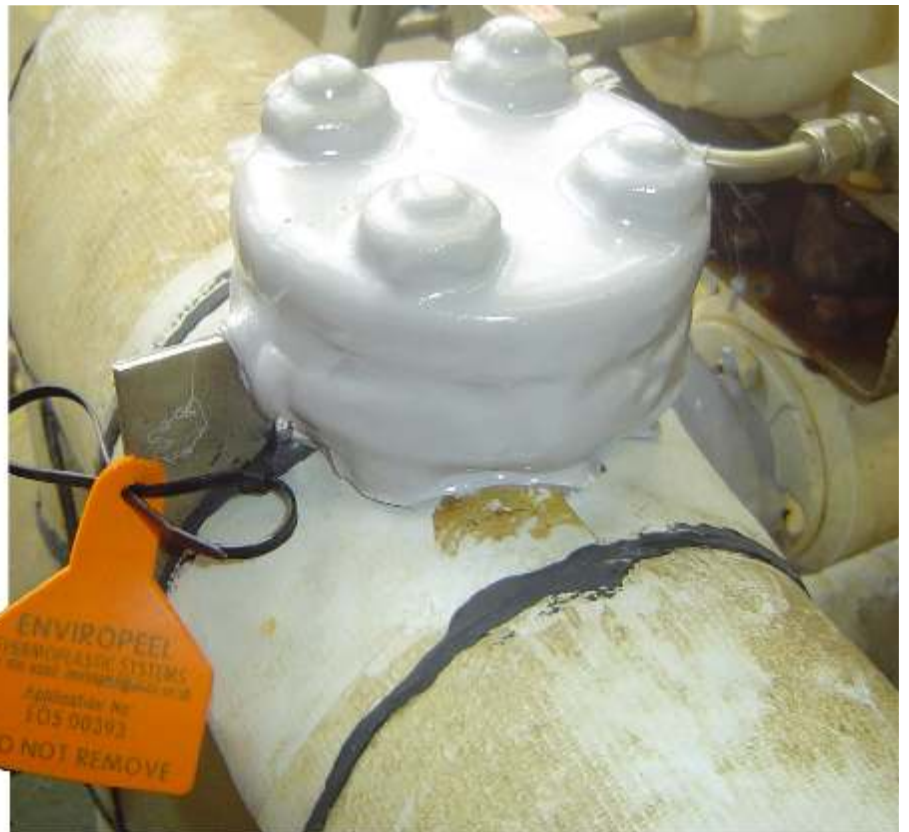
Right: As part of Enviropeel's ongoing development of asset maintenance services for its clients, a complete tagging and recording system has been implemented that identifies operator, time date and ambient conditions during each individual application.

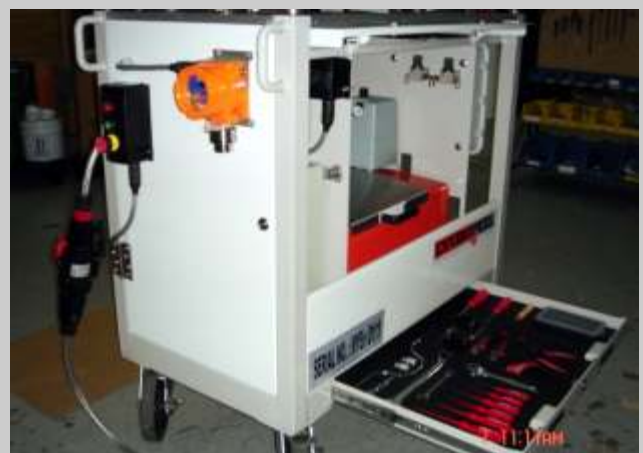
## THE ZONE 2 UNIT

The applicator consists of a heating and pumping unit, an ATEX certified temperature-controlled hose and spray gun, all constantly controlled and monitored by the inbuilt microprocessor. All components are housed in a purpose-built mobile trolley and protected by a gas detection system, incorporating EXD electrical enclosures and an EX-rated Emergency Stop Station. It is DNV certified for use within a flammable atmosphere with ATEX and EXD components and a safety system that is designed to isolate the entire unit if any potential risk is detected.
