STEEL REFURBISHMENT

In the beautiful northern UK area of Cumbria, the structural steel and landings of this spiral staircase inside a Victorian valve tower were deteriorating badly. Alocit coatings were chosen because the steel is at dewpoint throughout the year and in urgent need of protection, but the wet substrate made preparation and coating very difficult.

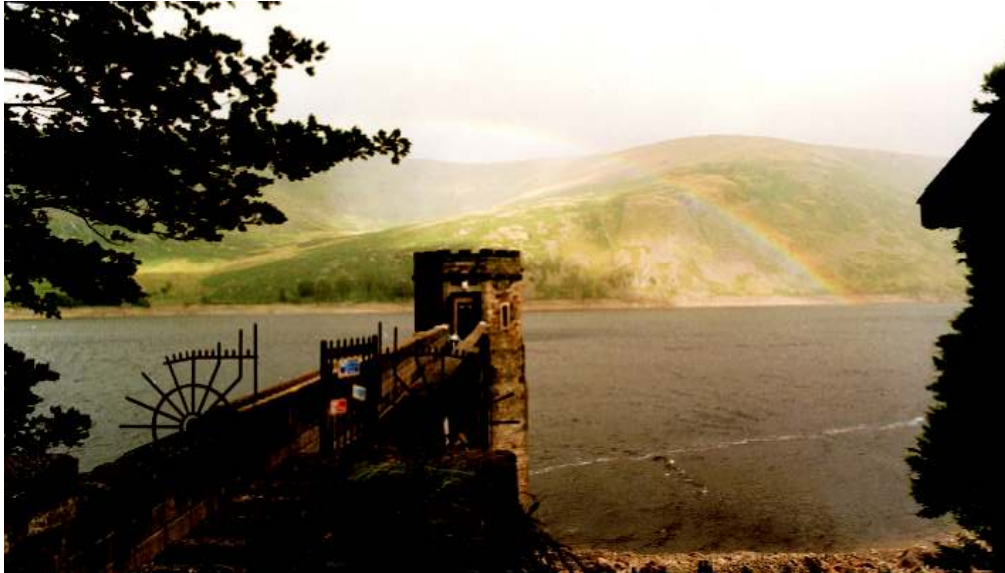
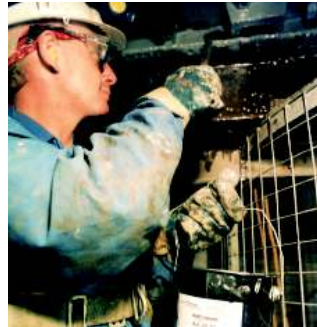
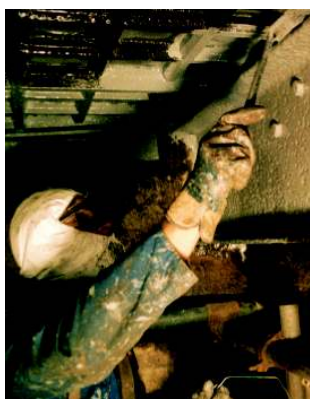
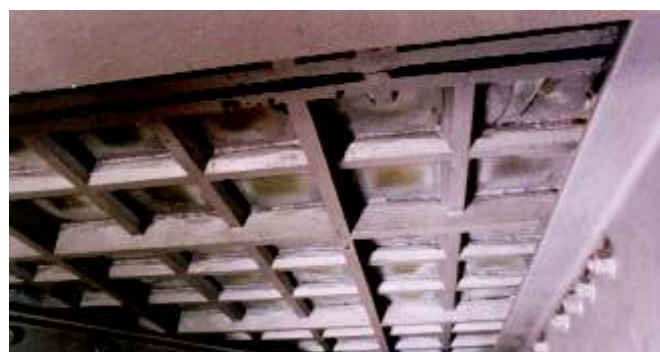
The pictures show the location, followed by all the stages of preparation and application.

Alocit's high tolerance for surface water and contamination such as flash rusting, residual salts and oil were key to the success of this project. The system used was an Alocit 28.14 zinc primer stripecoat followed by a full brush coat of 28.14 and a final brush coat of Alocit 28.15 in standard grey.

The surface was prepared by closed-circuit dustless vacuum blasting, minimising the risk of collateral damage to the structure and maximising coating adhesion.
